De-entrainment and washing of flash-zone vapors in heavy oil fractionators

Extensive troubleshooting experience shows what methods are most successful

D. W. Hanson, Process Consulting Services Inc., Houston, Texas; and **N. P. Lieberman** and **E. T. Lieberman**, Process Improvement Engineering, Metairie, Louisiana

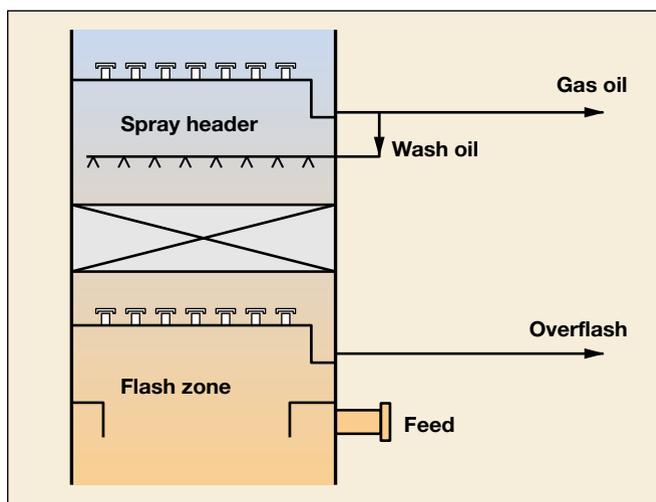
Fig. 1. Typical layout of a heavy oils tower.

When a wash oil bed cokes, the pressure drop increases (Fig. 1). This creates localized high vapor velocities as the coking “chokes off” some of the tower’s open area. Since the bed does not coke evenly, high vapor velocities will promote high entrainment in these areas.

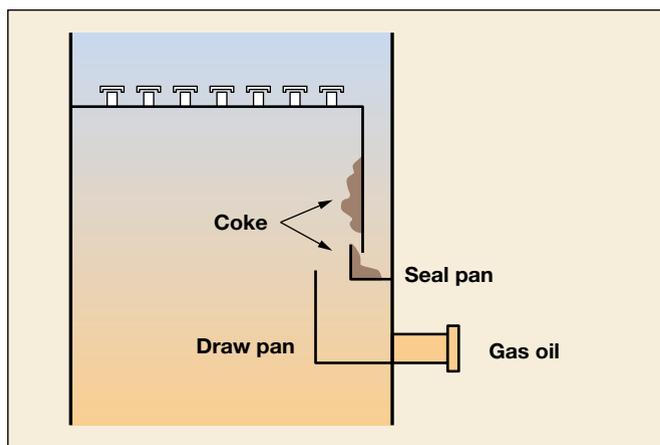
Fig. 2. Coked gas oil draw tray.

more) and is frequently found below the gas oil draw pan (Fig. 2). This wall coke often falls from the wall onto the wash oil grid or vapor horn distributor. The significant feature of this wall coke is that it is forming on a vertical surface.

Coke formation on vertical surfaces is usually a more urgent problem than coke formation on the topside of a horizontal surface. This is because coke forming on vertical surfaces eventually falls off and causes problems for the tower internals. For example, in one visbreaker fractionator, coke breaking off the outside of a downcomer restricted and prevented flow into the draw-off pan below (Fig. 2). This caused a premature unit shutdown.

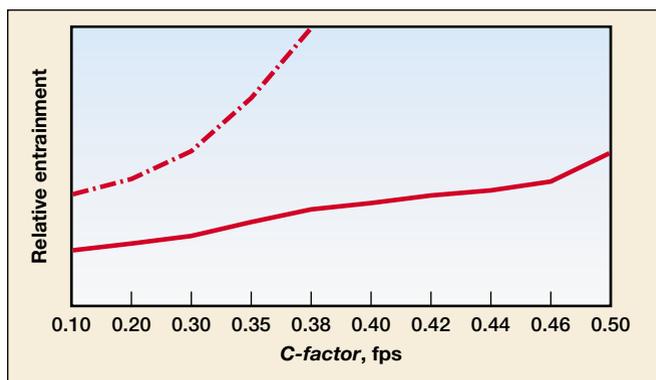
Fig. 3. Relative de-entrainment comparison.

With over 200 industry applications in high-vapor-rate vacuum services, we have correlated expected entrainment vs. *C-factor* in Fig. 3. Compared to other flash-zone distribution devices on the market (dashed line), the vapor horn (solid line) has proven to be both an effective vapor distribution and de-entrainment device as its entrainment curve stays essentially flat until high *C-factors*. With other vapor distributors, the entrainment increases exponentially above a *C-factor* of 0.32 fps. The vapor horn has maintained very high de-entrainment capabilities at *C-factors* approaching 0.46 fps.

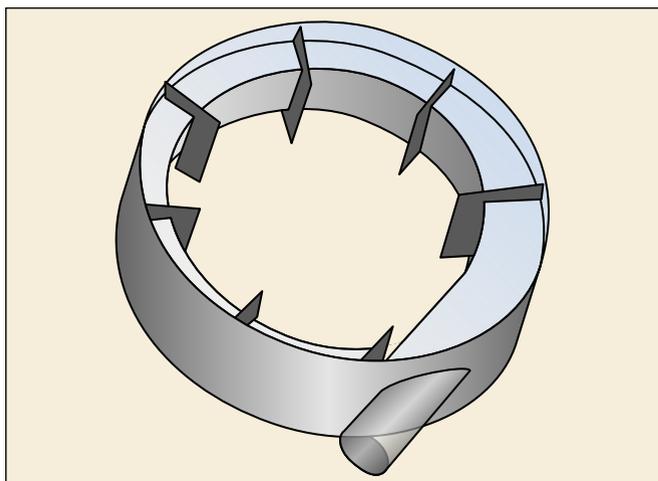
Fig. 5. Tangential vapor horn.

The first item on this list is an excellent rule-of-thumb. In revamp after revamp, we have seen gas oil quality greatly improve by increasing the vertical height of the flash zone. In one revamp, we modified an older-style vapor horn using all of these guidelines in a virgin crude vacuum column operating on Venezuelan crude. The revamp results were excellent. The tower diameter was over 30 ft. The unit was plagued by poorer-than-expected gas oil quality that limited an increase in cutpoint. The vapor horn was modified, using the guidelines, and the heavy vacuum gas oil (HVGO) quality improved enough so that the refinery was able to increase cutpoint by 10°F to 15°F. Fig. 5 is a schematic of the vapor horn that was used. The cut-off vanes are not shown due to the view.

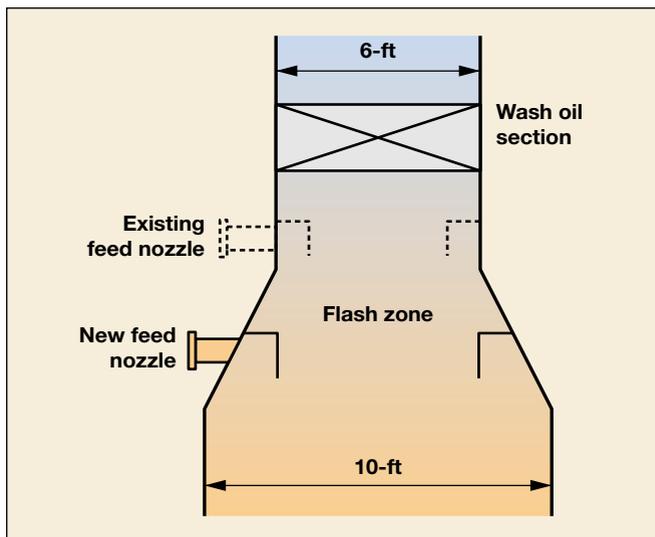
Fig. 6. Recovered lube oil vacuum column flash-zone revamp.

Recovered lube oil vacuum column. We have worked extensively on a vacuum column in this service. Additives in the waste oil caused a polymerization reaction that plugged the wash oil grid, as shown in Fig. 6.

To solve the entrainment problem that was causing the coking, we lowered the feed nozzle into the "swedged" section of the tower. This effectively reduced the entrainment velocity at the feed nozzle elevation.

A result of this change was an increase in run length. By improving the vapor distribution and de-entrainment, the refiner increased run length six-fold, from one month to six months. We are working with this refiner on other solutions to increase the run length even further.
