Field Data, New Design Correct Faulty FCC Tower Revamp

In 1987, Lyondell Petrochemical Co. revamped a fluid catalytic cracking unit (FCCU) main fractionator by replacing trays with structured packing. This revamp did not achieve its design objectives; therefore, a second revamp was performed in 1992. Packing large diameter main fractionators can increase unit capacity and decrease pressure drop while meeting fractionation objectives. However, a packed main fractionator revamp is less forgiving than a trayed column revamp and must take into consideration proper design and inspection procedures. Lyondell's experience illustrates the approach needed to have a successful structured packing revamp.

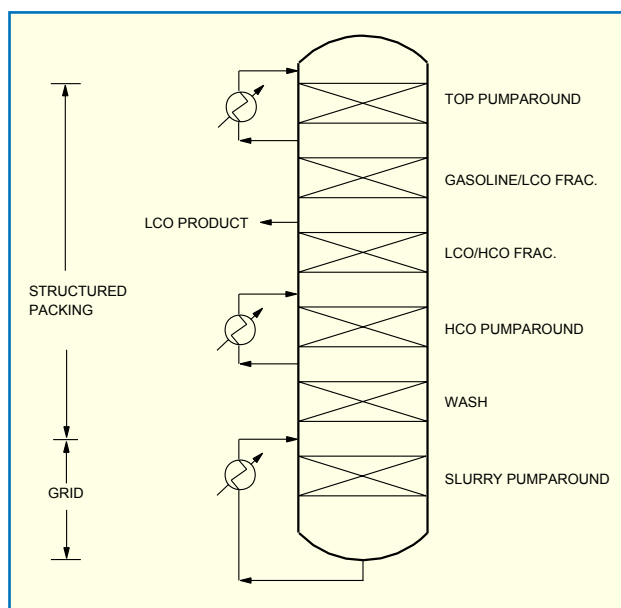
Figure 1 Initial Column Revamp

The 79,000 b/d FCCU main fractionator at Lyondell Petrochemical Co.'s Houston refinery was first revamped from trays to structured packing in 1987 (Figure 1). The justification for the revamp was a capacity increase to 92,000 b/d. An ultimate capacity of 100,000 b/d was anticipated, at the same gasoline cutpoint as the trayed column, and at reduced column pressure drop. The revamp design gasoline D86 endpoint was 445°F.

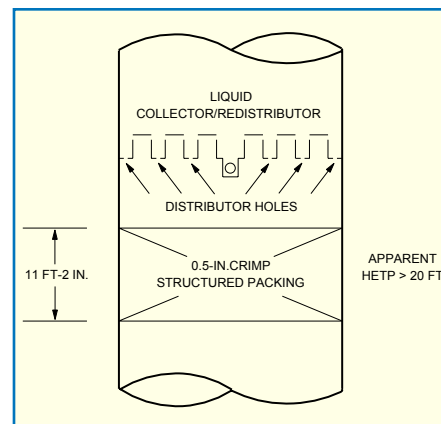
Figure 4 Gasoline/LCO Fractionation

- The measured column pressure drop was near the design value. The individual bed pressure drops could not be measured because no instrument taps were installed (and low pressure drop is difficult to measure accurately.)
- Field testing showed poor fractionation throughout the column. Poor initial distribution and/or little or no remixing of internal liquid often cause poor fractionation. Poor liquid distribution causes variations in liquid/vapor ratios across the tower cross sectional area, which result in composition gradients. Figure 4 is a schematic of the gasoline/LCO fractionation section. This bed had approximately 0.5 theoretical stages, or an apparent height

equivalent of a theoretical plate (HETP) of greater than 20 feet. Refinery main fractionator beds are short (3-8 theoretical stages) and the columns are typically large diameter. If one cross-section of the bed has an L/V ratio much lower than another section, the result will be high endpoint material leaving the low L/V section of the column. Lyondell concluded that there was poor liquid distribution and the consensus was that structured packing does not work in large diameter FCC main fractionators. A test run was planned to gather additional field data.

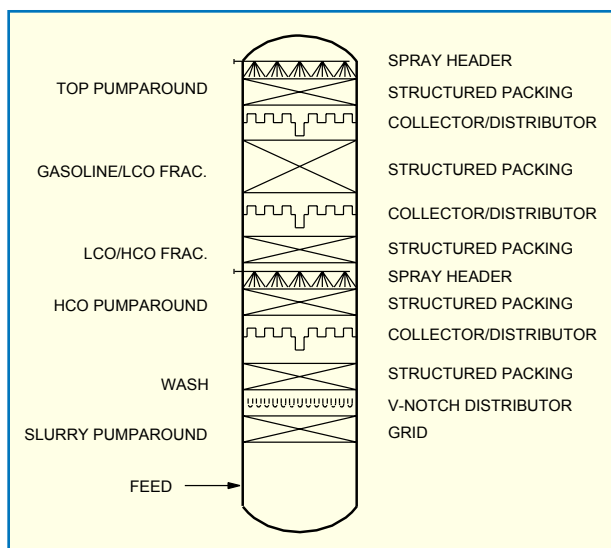
Figure 6 Original Packed-Column Internals

The first revamp was done to increase capacity and raise conversion. Lyondell decided to replace the trays with structured packing. The baffle trays were replaced with grid and the remainder of the internals with structured packing. The packed column hydraulic design was consistent with 100,000 b/d fresh feed at 75% conversion, although the unit capacity was limited to 92,000 b/d because of environmental permit limitations. A new wet flue gas scrubber planned for 1994 would allow operation at as much as 102,000 b/d. Table 3 summarizes the fractionation bed depth and design packing performance. The column has two pumparound side draws and one product side draw (Figure 6).

A combined liquid collector/redistributor was selected to decrease the height required for pumparound/product draws, which allowed maximum packed bed depth. The design column pressure drop was 0.8 psi. The packed column started up in early 1987.

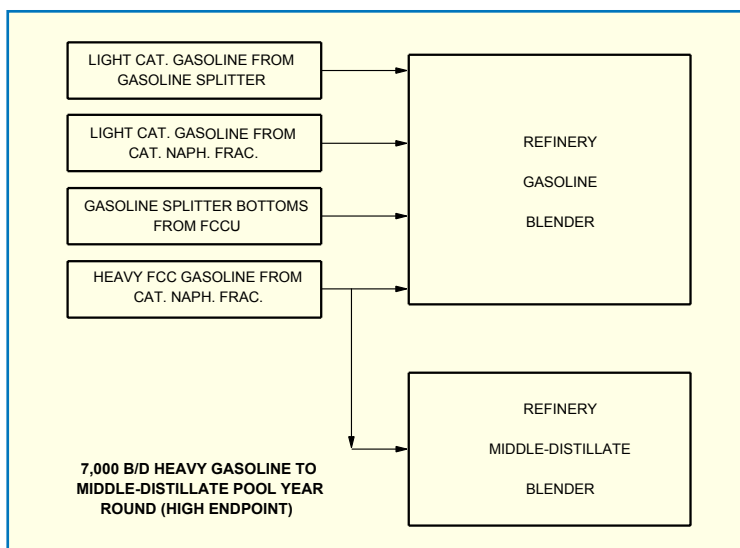
Figure 7 Blending Problems-High Endpoint FCC Gasoline

The packed main column was producing high endpoint gasoline and the LCO product contained a large amount of gasoline. Poor fractionation caused 2,400 b/d of gasoline loss directly to LCO product. However, the main problem was the high endpoint gasoline. Of the total FCC gasoline production, about 7,000 b/d had to be

blended to the refinery middle distillate pool year-round (Figure 7). During winter months, the refinery operated in maximum middle distillate mode, and the 7,000 b/d was typically needed for middle distillate production. Therefore, during gasoline season, 14% (excluding gasoline lost to LCO) of the FCC gasoline production was lost to the middle distillate pool, which had a major impact on refinery economics. The heaviest portion of the FCC gasoline has a low RVP relative to average FCC gasoline. The impact on the total refinery gasoline pool is thus greater than the volume loss of 7,000 b/d. The two possible solutions were to replace the packing with trays or fix the packed column.

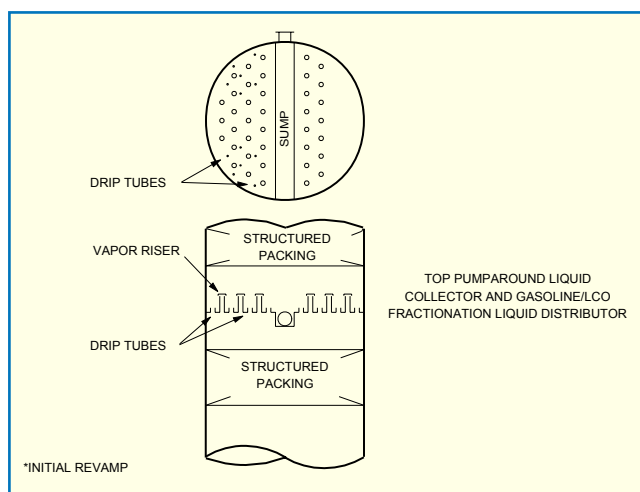
Figure 8 Blending Problems-High Endpoint FCC Gasoline

Packed columns do not fractionate where there is poor liquid distribution, flooding, and/or poor vapor distribution. The initial revamp used a combined collector/distributor to maximize packing bed depth. Figure 8 shows the combined top pumparound liquid collector and gasoline fractionation section distributor. The top pumparound design rate was about 6,000 gpm, while the design internal liquid rate to the fractionation section was about 3,500 gpm. A combined pumparound collector and liquid redistributor device has never been used successfully in large diameter fractionators. To illustrate, Table

has one bad distributor and good mixing at the lower redistributors eliminates the propagation of the composition gradients down the column. In an effort to reduce investment and increase packing bed depth, a combined liquid collector and orifice pan distributor was used. An orifice pan distributor should never be used in large diameter refinery columns. The collector/distributor had a wide sump with a draw nozzle at one end. There were no drip points in the sump, leaving a large part of the packing without initial distribution. The pumparound collector/distributor also had a significant liquid gradient from the side opposite the pumparound draw to the draw nozzle. An attempt was made to modify the collector/distributors by installing drip tubes in the sump and using a second nozzle opposite the first. These modifications made little or no improvement in column performance.

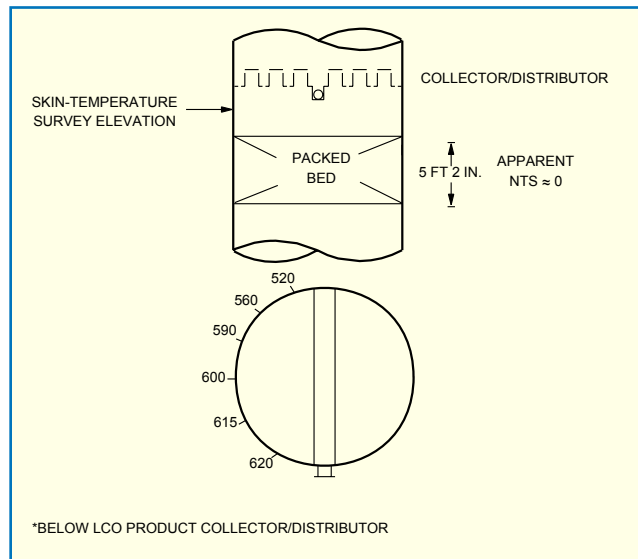
Figure 10 Skin Temperature Above LCO Draw

Figure 9 shows a radial survey taken below the top collector/redistributor. The temperature varied from 495°F near the draw nozzle to 360°F directly opposite the pump-around draw nozzle. Figure 10 is a radial skin temperature survey taken above the LCO product draw tray. The skin temperature data showed there was severe liquid maldistribution throughout the column. Compositional gradients caused by poor initial liquid distribution were never corrected at lower elevations because the combined collector/distributor provides no remixing. A column that

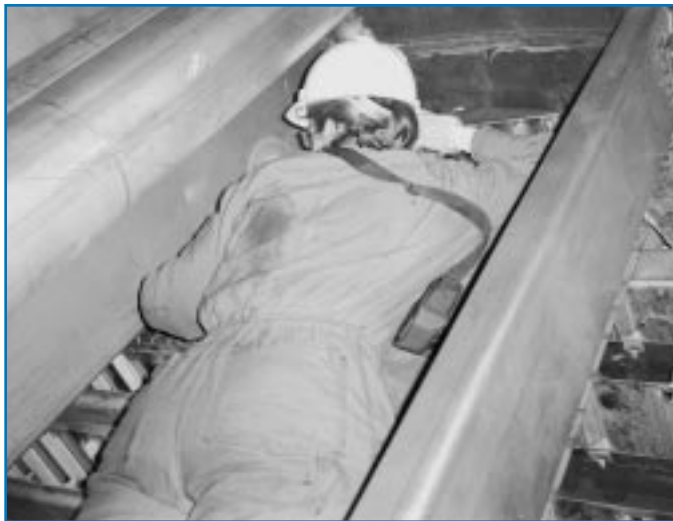
Photo 1 Thorough Packed Column Internals Inspection

A checklist of all the items to be field inspected was made before the shutdown. An experienced engineer should inspect the column internals before the manways are closed (Photo 1). Many columns fail because there is no one person responsible for this activity. A column should not be inspected by committee or by an inexperienced engineer because the job is critical.⁵ Inspections also should not be made for the sole purpose of identifying that the equipment was manufactured per the drawings. Sometimes something is designed incorrectly, but built and installed correctly. The inspection is the last opportunity to catch mistakes that cause shutdowns (Photo 2). Many columns have to be shut down for modifications after a revamp, which is much more costly than correcting an error before start-up.^{6,7}

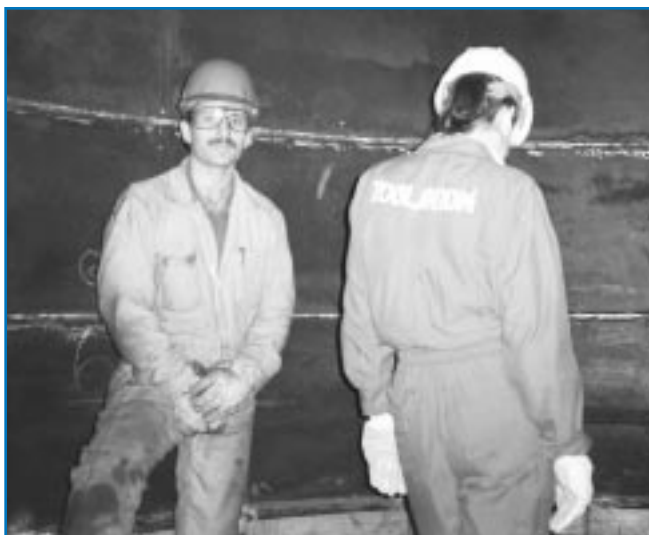
Photo 2 Final Inspection: Last Opportunity to Correct Mistakes
