Correcting Design Errors Can Prevent Coking in Main Fractionators

Scott W. Golden

Norm Lieberman

Gary R. Martin

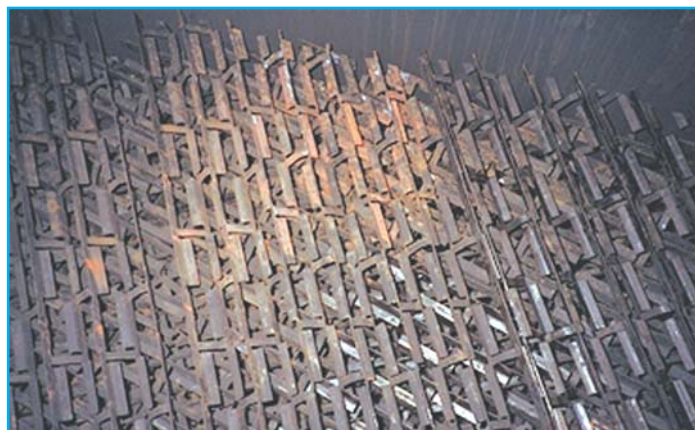
Photo 2. Clean Packing

The use of packing in refinery main fractionators at low liquid rates is common (**Photo 2**). Using packing in the desuperheating section of an FCC main fractionator has process, efficiency, and mechanical advantages over shed or disc-and-donut trays. But while packing has the advantage of inherently low hold-up or res-

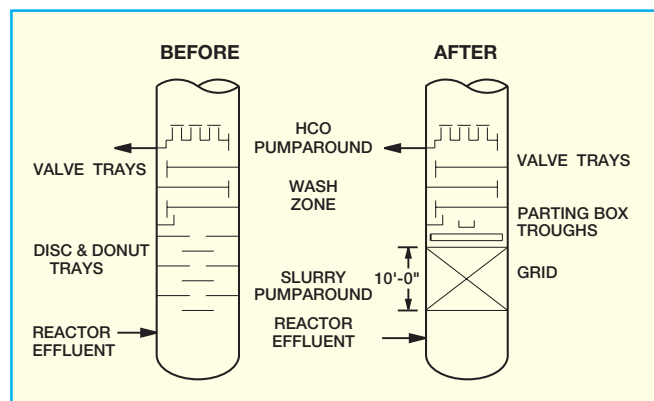
Figure 1 FCC Slurry Pumparound Revamp

The disc-and-donut trays of a 95,000 Bpd FCC main fractionator (Photo 3) were replaced with grid to improve the efficiency of the pumparound section (Figure 1). The objective was to decrease the light cycle oil (LCO) content of the decant oil product leaving the bottom of the column.

The revamped column ran well for about 3 months, and then the pressure drop across the packing began to increase. The cause was thought to be the depth of the grid bed. Like many troubleshooting solutions it was solved in the office and not the field. The initial solution was to reduce the packed bed height. This was solely based on calculations of the heat transfer coefficient. The calculated main column unquenched bottom temperature was 875°F. In this case, the engineer failed to take into account vapor/liquid equilibrium. In fact, because the liquid rates are so high

Once the packing began to coke liquid hold-up increased. Liquid hold-up would cause the pressure drop to gradually increase to about 3 psi, and then the liquid in the bed would dump, which rapidly decreased pressure drop. This upset the reactor-regenerator pressure balance and caused high liquid level in the bottom of the column.

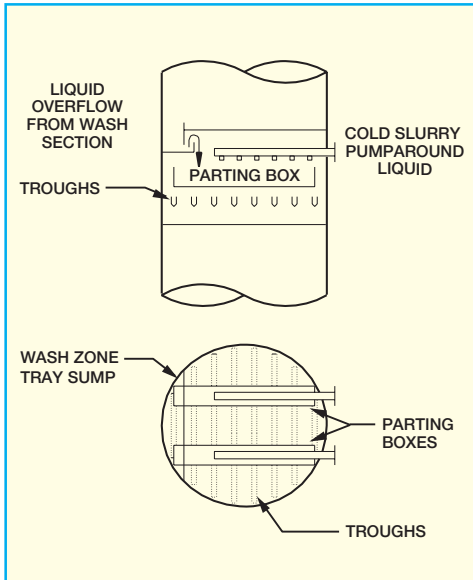
Figure 2. Packed Column Internals

In this design, the wash liquid was fed into the slurry PA liquid distributor from the one-pass trays, as shown in Figure 2.

The liquid distributor design preferentially fed the wash liquid to one section of the packing and the slurry pumparound liquid to another. Inspection of the packing

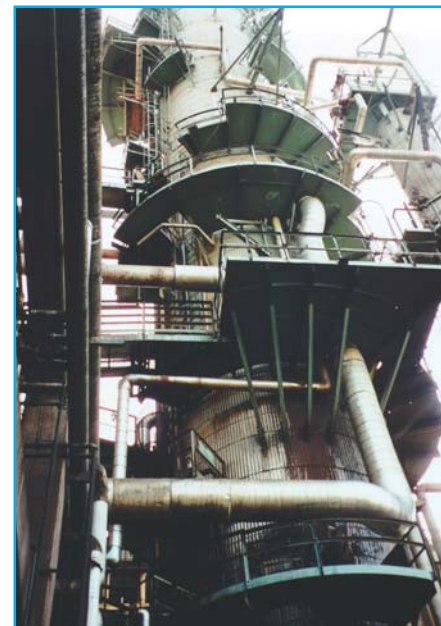
Photo 4. Packed Coker Column

A delayed coker main fractionator (**Photo 4**) wash section was revamped from tray to packing to increase unit charge rate and reduce recycle rate. Four sieve trays were replaced with an 8-ft. bed of grid. However the packing began to coke after less than 6 months of operation. The packed bed pressure drop increased from 6 inches of water just after start up to over 32 inches after only 6-month period. **Figure 6** shows the column before and after the revamp. To reduce the initial revamp costs, the collector tray under the wash bed was not modified and the shed trays below the collector were not removed (**Photo 5**).

Once pressure drop increased above 18 inches the asphaltene content increased rapidly and coke fines were carried into the HCGO product. The coke fines plugged the down stream hydrotreater feed filter system and caused chronic operating problems. After just 6 months the column was shutdown and the grid replaced.

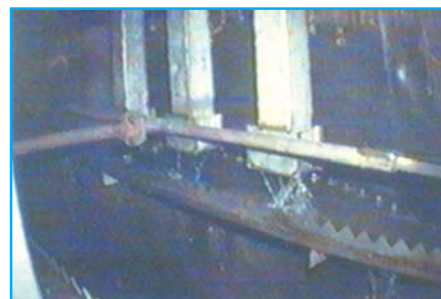
Photo 5. Shed Trays

Shed trays in delayed coker main fractionators serve no useful purpose. They are a remnant of the era of high recycle and sieve tray wash sections. Most refiners have removed them because they constantly coke and often are mechanically damaged. Fundamentally shed tray design and operating principles dictate they operate well only at high liquid rates. Six-pass shed trays have very high weir length, hence they would require over 30% recycle to establish sufficient liquid level over the weir to provide good liquid distribution. Furthermore they would need to be perfectly level or distribution would still be poor. Delayed coker main fractionators

After several more unscheduled shut-downs the sheds were removed. Removing the sheds allowed the collector tray design to be modified to a single downcomer and the coking on the collector tray was eliminated (Photo 7). The coking problem has not recurred.

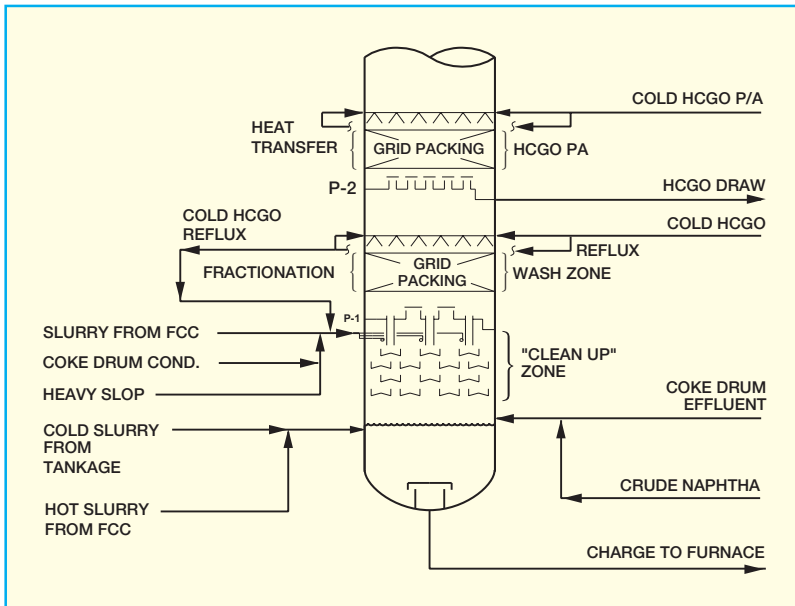
Figure 7. Delayed Coker Fractionator

Equipment design is not the only source of most problems. Process flow schemes always interact with the equipment, and thus understanding both is necessary when troubleshooting. Process stream flows are shown in Figure 7.

Reviewing the flow scheme showed a fundamental flaw. Cold HCGO was fed to both the wash bed and to the shed trays below the wash bed. Thus, the liquid rate feeding the wash section packing was not being maximized. The cold HCGO flow to the wash bed was 9,000 b/d and to the shed trays was 5,000 b/d. The cold HCGO feeding the shed trays, in theory, cooled the rising vapor prior to it entering the wash section. Three separate 4-inch nozzles with internal pipes were used to distribute the cold HCGO onto the six-pass shed trays. However, feeding cold HCGO onto the sheds lowered the wash section

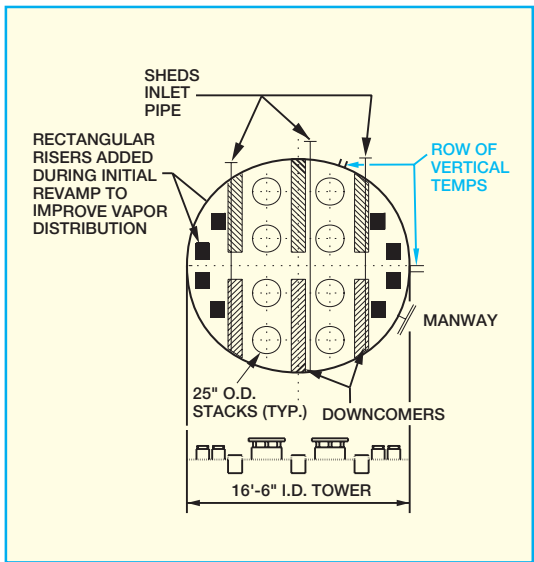
Figure 9. Coker Wash Section, Initial Revamp

higher wash oil flow dramatically reduced coking in the wash bed. Vapor distribution was poor because the collector tray design below the bed (Figure 9) did not uniformly distribute vapor. In addition, the collector tray below the packing had to distribute liquid to the six shed trays and it is very difficult to distribute a small amount of liquid internally.

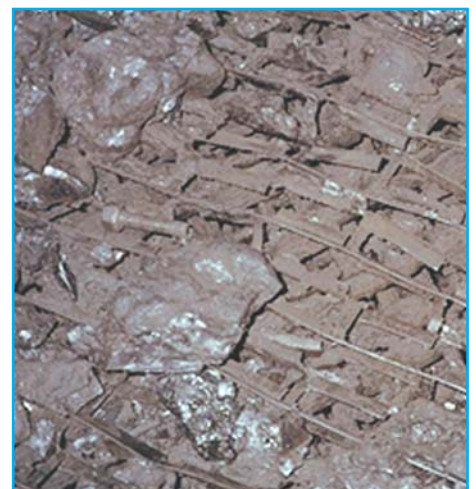
Photo 9. Coked Wash Zone

black. When the pressure drop increases to 8-10 mm Hg, gas oil quality will be very poor. Pressure drops as high as 80 mm Hg have been measured across vacuum columns wash sections (Photo 9).

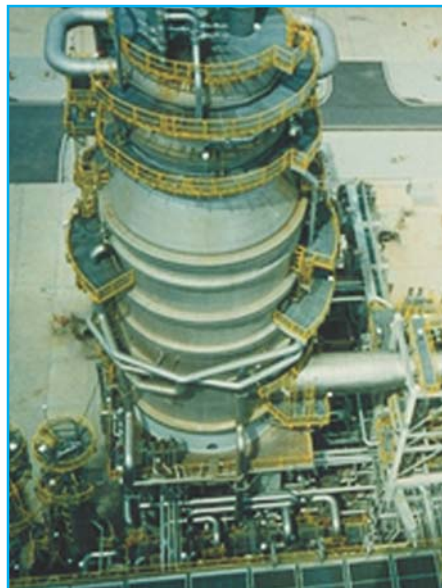
Photo 10. Vacuum Transfer Line

Typical process simulation models are structured assuming all the feed entering the vacuum column flash zone is in equilibrium. But this assumption is not correct because vapor and liquid in the transfer line (Photo 10) from the heater to the vacuum column are not in equilibrium. Transfer line phase separation generates superheated vapor and causes more of the wash oil to vaporize than is predicted by the typical process model structure.

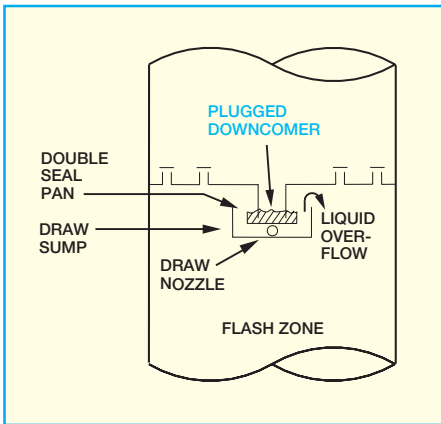
Figure 12. Hydrocracking Vacuum Column-Overflow Pan

Why? The overflow recycle pump had never been commissioned. While the overflow pan did have a provision for internal overflow, the authors had made mistakes (Table 4) in design (Figure 12). When the tower was shutdown, the wash oil grid was replaced. Since that time, the overflow pump has been run continuously and the HGO quality has remained excellent. The lesson from this incident is that a 100% reliable provision for internal overflow of overflow liquid is critical for vacuum towers processing thermally degraded feedstocks.

- The slop wax collector draw-off sump had a high residence time before it would overflow.
- If the slop wax pump was running, the liquid level in the sump was low, and coking would be retarded.
- When the pump was not operating, the draw-off sump coked (Photo 11). With a virgin vacuum column, the temperature in the sump would not have resulted in a high rate of coke formation. But when processing thermally degraded feed, coking proceeds much more rapidly.
- Once the draw-off sump coked, flow to the overflow pan's internal overflow pipe was blocked.
- The slop wax began to overflow through the vapor chimneys, thus promoting entrainment of the slop wax into HGO product.
- The entrainment caused the wash oil grid to coke-off.

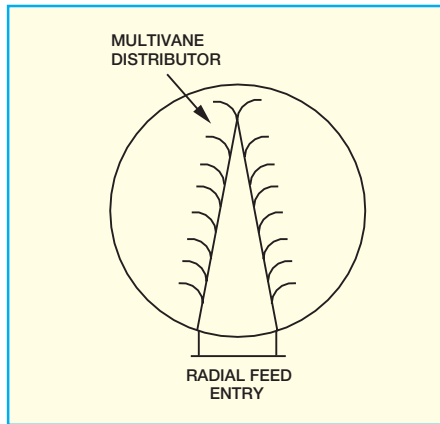
Figure 13. Hydrocracking Vacuum Column

The grid was removed and the wash oil nozzles were modified. Initial operations have produced a black HGO with 2 wt % Concarbon. It is the authors' opinion that the central problem with this design is the radial feed entry (Figure 13). These types

of entry promote resid entrainment and, as a consequence, wash section grid coking. The authors' recommendation is a tangential entry.
