Revamping FCC Units: Debutanizer Reboiler Fouling

Don't Treat the Symptoms

TONY BARLETTA, Process Consulting Services, Inc., Houston, TX

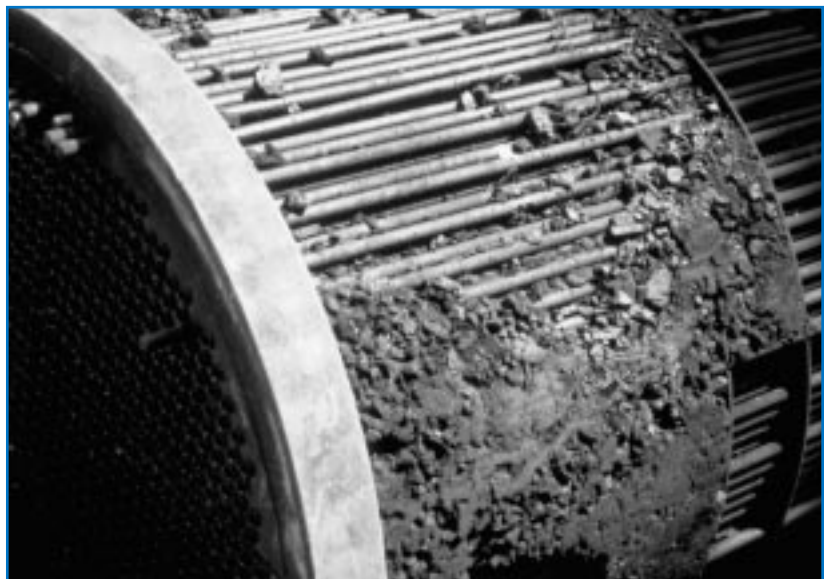
Photo 1. Example of localized fouling.

When shell-side fouling occurs, it is important to inspect the tube bundle to determine the exact location of the fouling. Often, severe shell-side fouling tends to be localized. A part of the bundle may be severely fouled, while the rest of the bundle may be relatively clean. When this is the case, rigorous heat exchanger modeling with a program such as Heat Transfer Research Institute's (HTRI™) IST program can help pinpoint areas of high localized tube wall temperature. High heat medium temperature increases the tube wall temperatures. In other words, high-heating medium temperature and exchanger design can result in very high localized tube wall temperature.

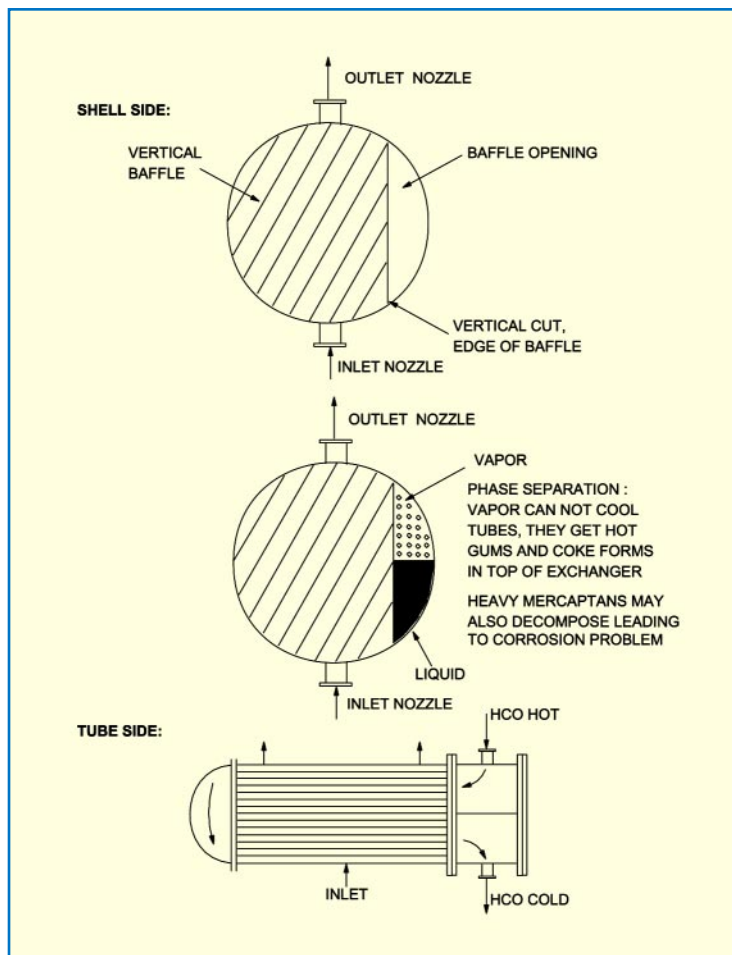
Figure 2. Baffle window phase separation.

The location of the coke indicated why the exchanger coked. The bundle coking and deformation was a result of the following items:

- Vapor/liquid phase separation in the window between the first and third baffles;
- Low heat removal where phase separation occurred, which increased tube wall temperatures; and
- High tube wall temperature, which increased the polymerization reaction rate.

High localized temperatures caused by vapor and liquid-phase separation in the baffle window between the first and third baffles caused the coking (Figure 2). Phase separation caused vapor to flow through the top of the bundle and liquid through the bottom. When the phase separation occurred, the tube wall temperature in the upper part of the bundle increased due to low mass flow (vapor density is low), whereas high mass flow (liquid) was needed to remove the heat. In addition, heat transfer coefficients are low for superheated vapor compared to liquid, the system experienced localized high outer tube wall temperatures that overheated the vapor, increased the reaction rate and formed coke.

Additionally, the tubes in the top part of the bundle expanded at a higher rate than the bottom of the bundle, which resulted in "bowing" and damage to the bundle and shell. The tubes directly below the outlet nozzle, where the hot HCO enters the exchanger, had no coke. Below the shell-side outlet nozzle there is no phase separation because the vapor and liquid flow together and keep the tube wall "wetted." Therefore, no overheating occurred in these areas.

Eliminating phase separation reduces outer tube wall temperature. In this case, this requires horizontally cut baffles with the baffle spacing selected so that "dead" zones in the exchanger are minimized. Horizontal baffles increase shell-side pressure drop. Higher-pressure drop decreases fluid circulation, and a complete system hydraulic evaluation must be done to ensure no other problems are created.
