# Diagnose flooding columns efficiently

Using field pressure data, a refiner made a low-capital modification on a crude distillation column to increase throughput without a shutdown

T. Barletta and J. Nigg, Process Consulting Services, Inc., Houston, Texas; and S. Ruoss, J. Mayfield and W. Landry, Tosco Refining Co., Belle Chasse, Louisiana

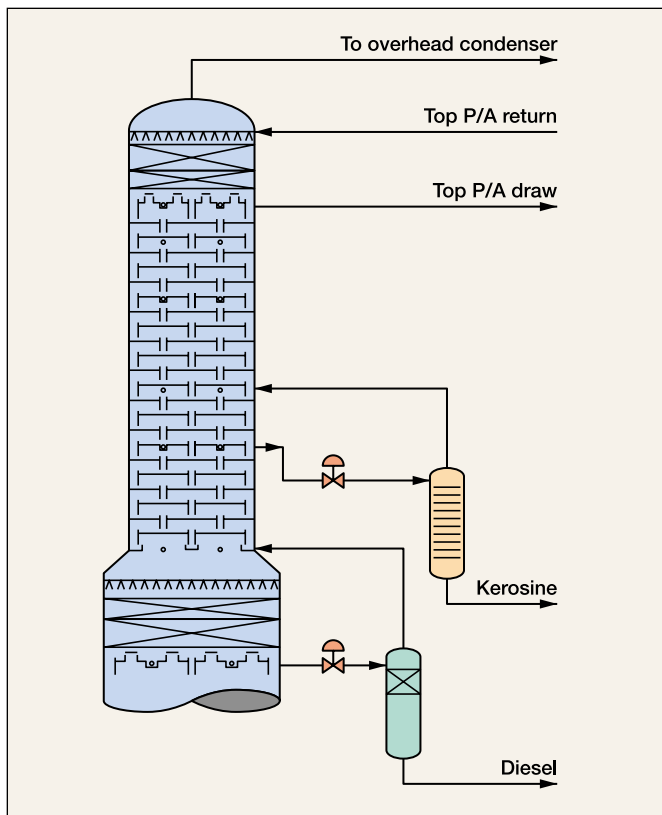
Fig. 1. Crude column upper section.

**Problem symptoms and consequences.** The Alliance Refinery crude column produces full-range naphtha as overhead product and kerosine, diesel and atmospheric gas oil (AGO) as product side draws. Fig. 1 shows an overview of the crude column's upper section, including the diameter swage at the diesel pumparound return. In early 2000, the crude column experienced severe upsets when the crude rate was

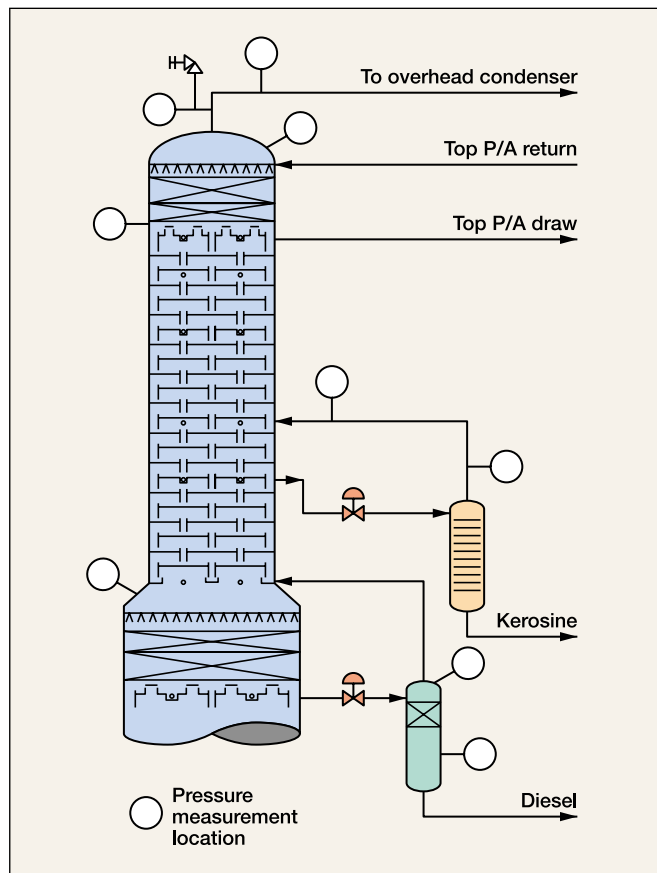
Fig. 2. Pressure measurement locations.

Pressure drop can be used to infer flooding, just as more sophisticated methods such as gamma scans. However, pressure drop can be much easier to interpret than a gamma scan. Pressure can be measured at column nozzles, stripper vapor line vents, draw nozzle low point bleeders, relief valve piping, and side-stripper bottoms level bridles. Fig. 2 shows the typical places where pressure can be measured.

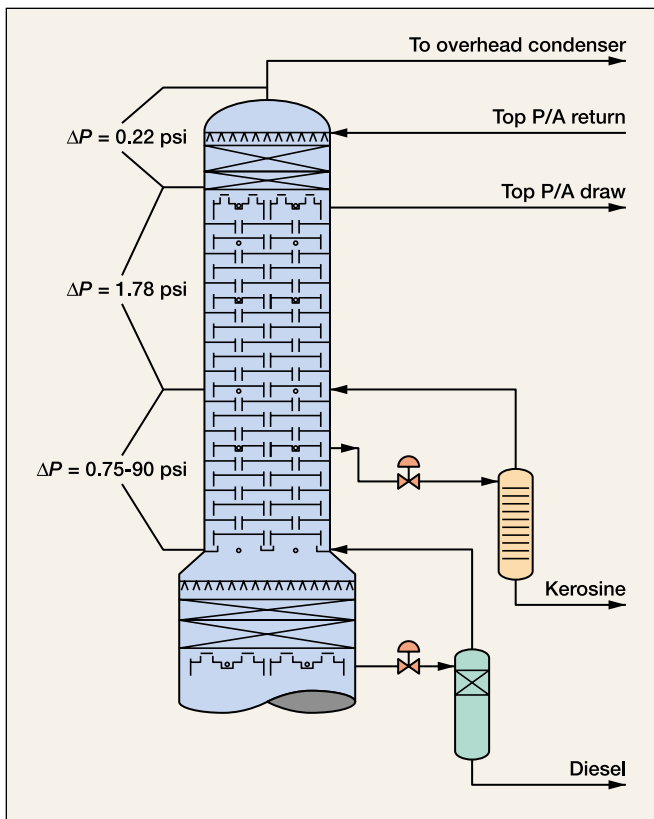
Fig. 3. Stable operation pressure drop.

Pressure profile—stable operation. The crude column pressure drop was measured when the column was in stable operation. Fig. 3 shows the measured pressure drops. The pressure drop across the top pumparound was about 0.20 psi and was measured over a 40-min period. It was stable during this period, fluctuating between 0.20 and 0.23 psi. At 0.20 psi pressure drop, the top pumparound bed was flooded. But

The pressure drop measured from above the collector tray to below the kerosine side stripper vapor return tray was approximately 0.148 psi per tray. This is high for standard valve trays. More field data was needed to determine if these trays were flooding and causing the upsets.

The measured pressure drops across sections of the column are shown in Fig. 3. The measured pressure drop across the section from the collector tray to the kerosine side stripper vapor return tray includes 0.39 psi of liquid head above the risers. Therefore, the actual pressure drop across these trays was 0.116 psi per tray. The measured pressure drop across the trays between the kerosine side stripper vapor return tray and the diesel side stripper vapor return tray was approximately 0.08 psi per tray. This does not indicate flooded or missing trays.

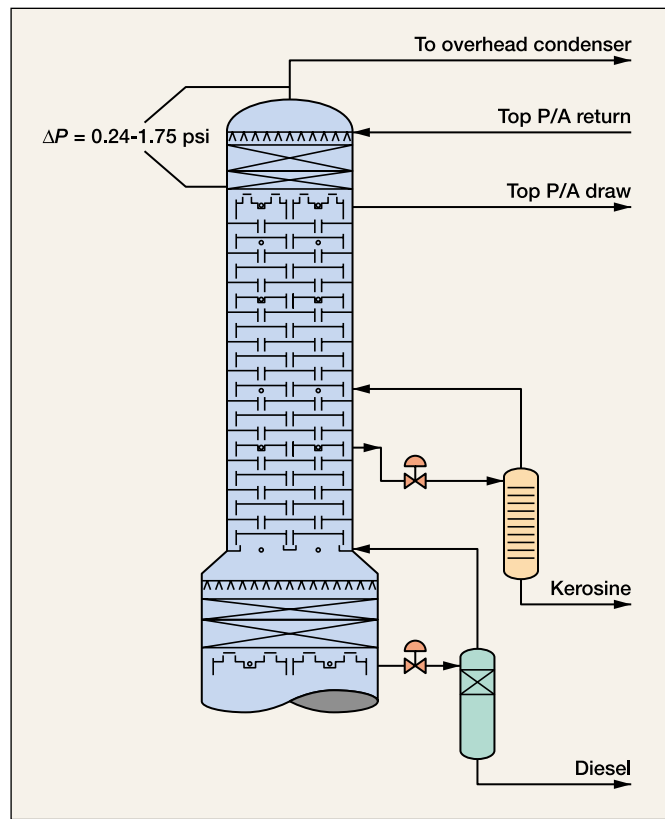
Fig. 5. Pressure drop during upset conditions.

Pressure profile—upset condition. Fig. 5 shows the pressure drop across the top pumparound bed during an upset. Pressures were measured at one of the 30-in. overhead lines and at a  $\frac{3}{4}$ -in. valve located 6 in. below the packed bed. The measured pressure drop was swinging between 0.2 and 1.75 psi. Yet, the calculated pressure

drop through the overhead nozzle is 0.06 psi. Therefore, the measured drop was essentially across the packing.

Pressure drop across the top pumparound bed is extremely high. This bed is highly loaded/flooded even at the lowest pressure drop 0.24 psi. The top pumparound bed is approximately 9 ft of structured packing. It is nearly full of liquid at a pressure drop of 1.75 psi. A pressure drop of 1.75 psi through the bed represents a liquid height in the packed bed of roughly 6 ft.

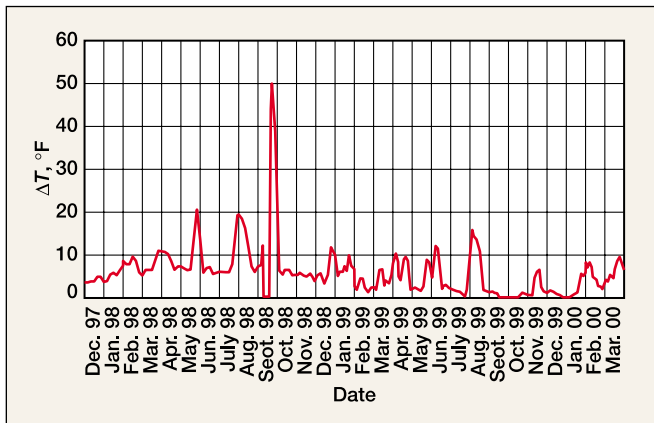
Fig. 4. Top P/A draw temperature minus overhead.

When a crude column top pumparound bed floods, the temperature difference between the tower overhead and top pumparound draw will decrease. The temperature difference should be in the range of 25–35°F. The temperature difference had been less than 10°F for the past two years prior to the upsets as shown in Fig. 4. Therefore, the bed had been operating flooded during the entire time. Even though the top pumparound bed had been operating flooded during this time, the unit had been able to achieve maximum throughputs.

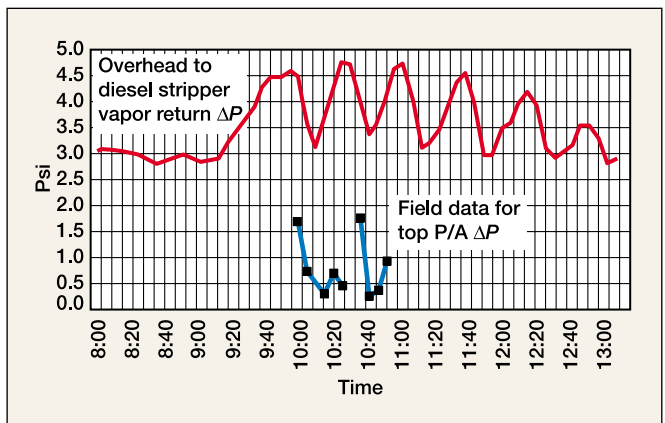
Fig. 6. Comparison of top P/A  $\Delta P$  and crude tower top  $\Delta P$ .

In Fig. 6, the (measured) top pumparound pressure drop and the pressure drop between the overhead and the diesel side stripper vapor return tray are compared. During the upset, the pressure drop between the column overhead and this tray cycles between 3.0 psi and 4.7 psi. The field-measured pressure drop across the top pumparound bed is also cycling at the same frequency by roughly the same amount. The increase in

pressure drop during the upset is in the top pumparound bed, not the trays below it.

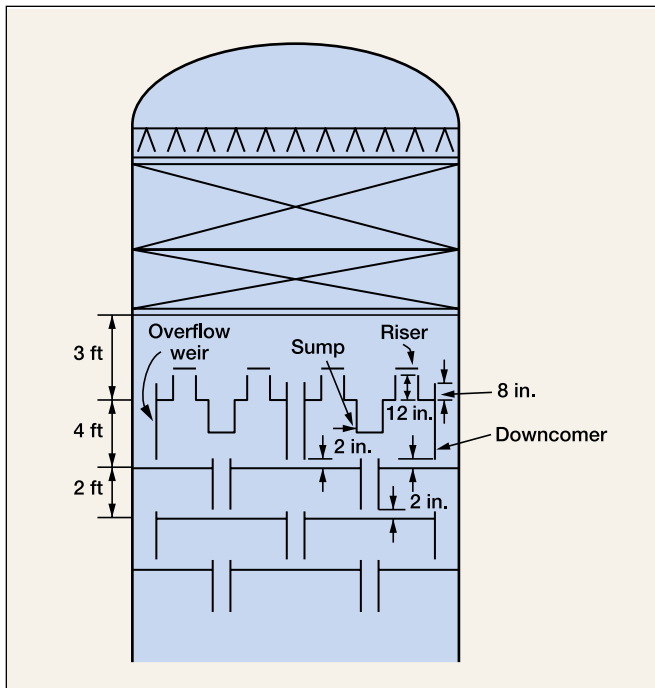
Fig. 7. Top pumparound collector tray.

Collector tray performance. A simplified sketch of the top pumparound collector tray is depicted in Fig. 7. The tray deck is located 3 ft below the packing and 4 ft above the tray below. Vapor from the tray below flows up through the collector tray risers and into the bottom

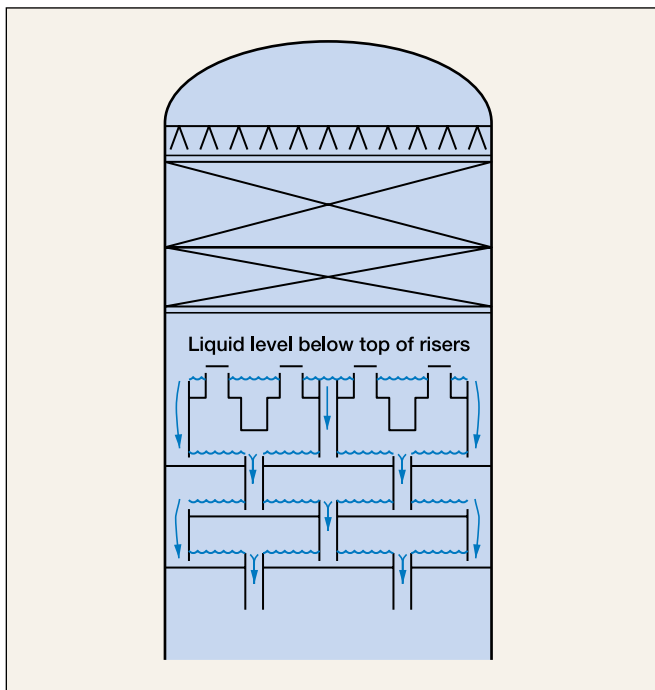
Fig. 8. Collector tray design liquid levels.

The collector tray is designed to operate with approximately 9½ in. of liquid on the tray deck. The liquid level should be below the risers, which are 12 in. high. Fig. 8 shows what the collector tray should look like with the design liquid level.

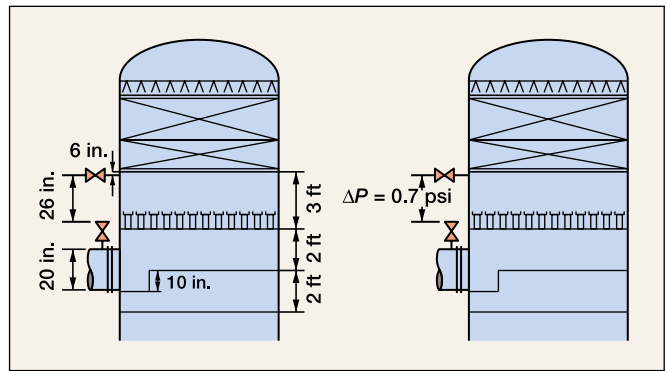
Fig. 9. Collector tray pressure survey.

water will exert 0.4329 psi of pressure head. Therefore, if the elevation between two pressures and the liquid density is known, then the liquid head can be calculated. Fig. 9 shows the collector tray pressure measurement locations and the elevation difference between them. The measured pressure drop was 0.7 psi, therefore, the collector tray is 100% full of liquid and is backing liquid up into the packing.

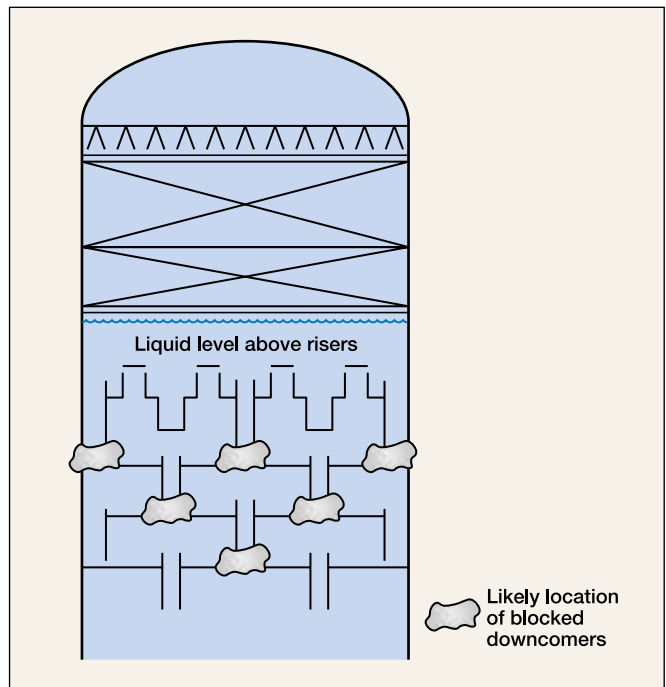
Fig. 10. Flooded collector tray.

**Interpreting field data.** Liquid was backing up onto the collector because of a restriction in one or more of the downcomers. The downcomer clearance is 2 in. The restriction was most likely due to salts, pieces of corroded packing and/or scale that has laid down on the trays and partially blocking off the area under the downcomer. The restriction was most likely in the collector tray downcomers or in the downcomers of the three trays directly below the collector tray. Fig. 10 shows a liquid collector full of liquid and the probable location of downcomer restrictions.
