Pump cavitation caused by entrained gas

Here's how the problem was solved on an FCC main fractionator

T. BARLETTA, Process Consulting Services, Houston, Texas

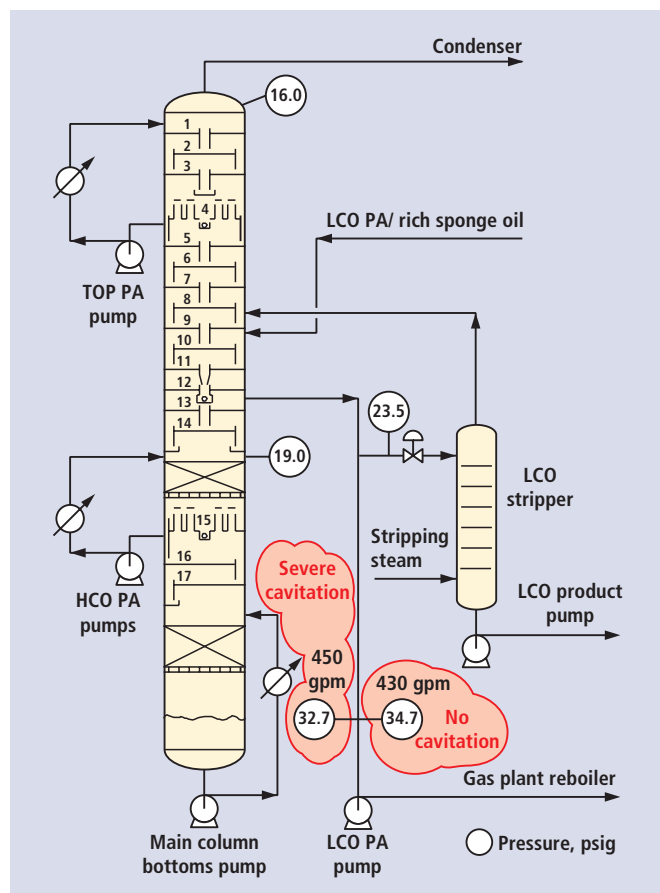
FIG. 2. Pressure and temperature measurements should complement scans when troubleshooting columns.

In this case, one of the scans showed the column was beginning to flood at tray #13, while the others showed no signs of flooding. Gamma scans are useful tools. However, they need to be planned, executed and interpreted by an experienced person. And they should not be the sole basis for troubleshooting. Often the troubleshooter must recommend shutdowns to correct design errors. Making a mistake can cost the refinery millions of dollars and not correct the problem's real cause. Temperature and pressure measurements³ are powerful troubleshooting tools (Fig. 2) and should complement scans when troubleshooting columns.

LCO PA system pressure survey. Several tests and pressure surveys were performed to determine the cause of pump cavitation. First, the LCO PA flowrate was reduced until flow and head were stable. A pressure gauge was installed on the pump suction above and below the pump strainers. This was done to ensure that nothing was plugging the strainers. The pump suction pressure was measured at 34.7 psig with the pump flow and discharge pressure both stable (Fig. 2). The metered LCO PA flowrate was 430 gpm with no signs of cavitation.

Increasing LCO product draw rate would also cause the PA pump to cavitate. LCO product and PA are both drawn from the same column nozzle with the line feeding the stripper located about 15 ft below the column draw nozzle. During the pump survey, the pressure was also measured at the inlet to the LCO stripper level control valve. Fig. 2 shows the measured pressure that indicated the suction line was full.

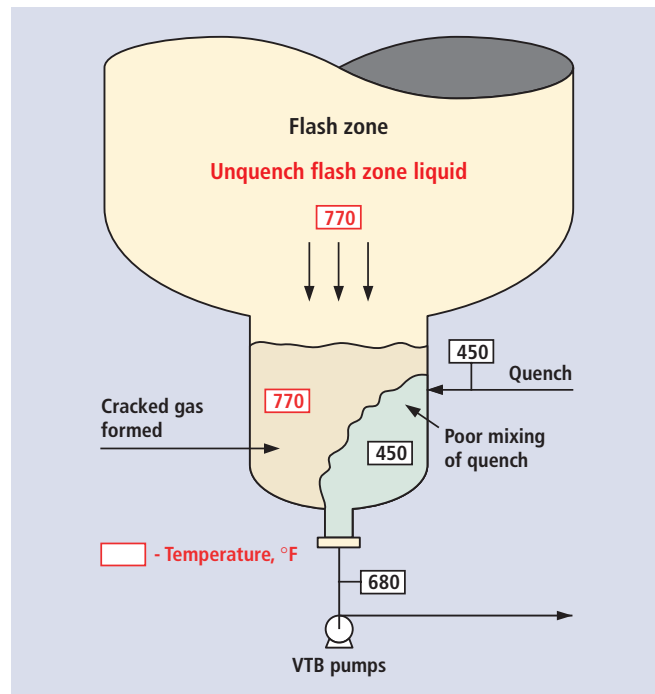
Pump cavitation—entrained gas. Vacuum tower bottoms (VTB) pumps are the most common service in a petroleum refinery where entrained gas causes cavitation. Gas bubbles formed by thermal cracking in the vacuum column bottom are entrained as the fluid flows into the column outlet nozzle feeding the pump suction line. Most vacuum column boots have no quench distribution. Thus, the unquenched flash zone liquid and boot quench do not mix until they reach the outlet nozzle (Fig. 3). Therefore, areas of the column boot are the same temperature as the flash zone.

FIG. 3. The unquenched flash zone liquid and boot quench do not mix until they reach the outlet nozzle.

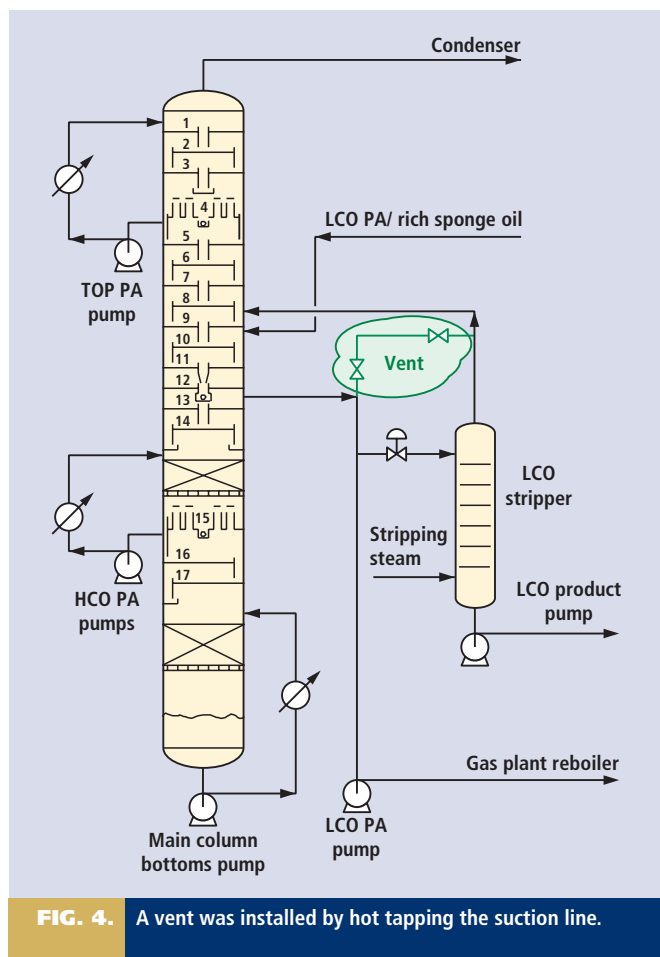
FIG. 4. A vent was installed by hot tapping the suction line.

Short-term fix—eliminating cavitation. If gas was being entrained in the liquid to the pump, then it was hypothesized that the gas could be vented. Hence, a vent was installed by hot tapping the suction line 90° elbow with the vent line routed to the LCO

stripper vapor return line running next to the pump suction line (Fig. 4). When the vent line was put in service, the pump began to operate stably at flowrates 25–30% higher without any indications of cavitation. The vent allowed the entrained vapor bubbles to flow to the stripper vapor line rather than the pump, which allowed the pump to operate smoothly. While this solved one problem, it did not address column flooding. Even at higher LCO PA flowrate, the column was still flooded, and the gasoline endpoint was high.

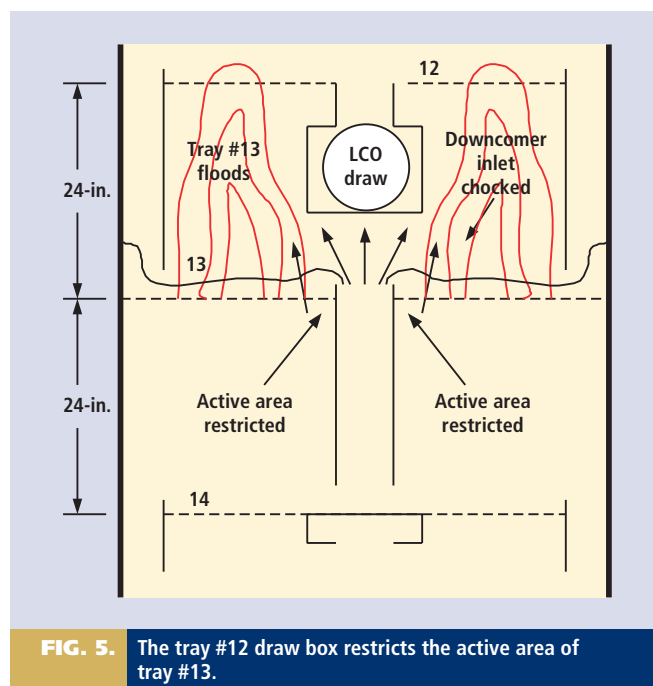
Column internals design—root cause. Field testing showed that flooding could be eliminated by increasing either the HCO or slurry PA flowrates. Furthermore, one of the gamma scans confirmed that the column was full of liquid from tray #13 to the top of the column. Fig. 5 is a schematic of the tray #12 draw box arrangement. The tray #12 draw box restricts the active area of tray #13 and chokes liquid flow into the tray #13 downcomer.

FIG. 5. The tray #12 draw box restricts the active area of tray #13.

Normally tray spacing is increased by 12–18 in. at draw locations to eliminate draw box (sump) interferences with the tray below. However, draw box modifications to reduce blockage of the tray #13 active area and downcomers are possible without increasing tray spacing. Fixing the problem requires a shutdown to modify the draw box. Small details often are the difference between success and failure. In the interim, the slurry PA duty was operated high enough to keep the column from flooding and gasoline on-specification. **HP**
