Revamp improves FCC performance at BP's Texas City refinery

Scott W. Golden
Daryl W. Hanson
Process Consulting Services Inc.
Houston

Joy Hansen
Mike Brown
BP Products Co.
Texas City, Tex.

In early 2003, BP Products Co. revamped its Texas City, Tex., refinery. Changes to FCC Unit 1 reduced the true boiling point distillation curve's 90%-final boiling point tail for the heavy catalytic naphtha (HCN) to 36° F. from 58° F., lowered gasoline sulfur content,¹ and improved gasoline recovery from the light catalytic cycle oil (LCCO) by 800 b/d.

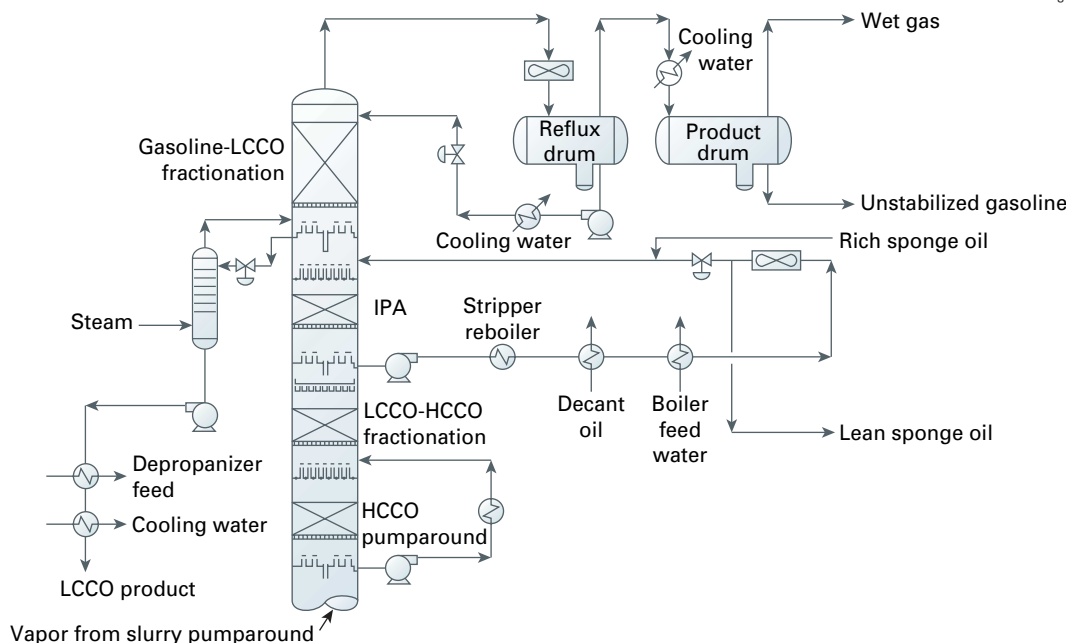
Fig. 1 shows the main fractionator

process flow scheme before the 2003 revamp. A review of the existing process flow scheme showed that the heat balance was flawed because sufficient heat removal was unavailable above the LCCO product draw. This resulted in a periodic loss of level in the LCCO product stripper.

In the summer, total condenser plus subcooler heat removal was insufficient at

high feed rates and maximum conversion. Heat removal did not allow stable control of LCCO product yield because the LCCO product was withdrawn from above the intermediate pumparound (IPA).

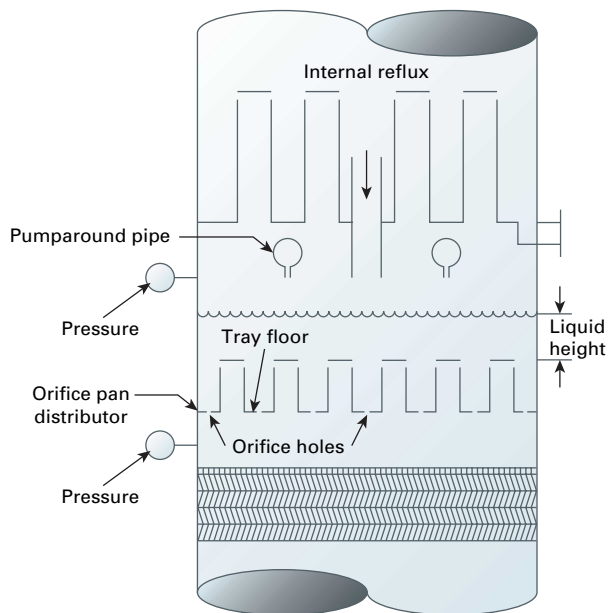
Fig. 2

A detailed review of the IPA distributor (Fig. 2) operation showed that internal reflux from the LCCO product collector fed onto the middle of the orifice pan distributor, while the IPA return stream was fed by two off-center pipes.

Flooding occurred at high IPA flow rates because the liquid level reached the top of the orifice pan distributor's risers and IPA liquid carried up the column into the gasoline-LCCO fractionation bed.

Distributor liquid handling capacity was much less than expected because the IPA stream contained rich sponge oil that vaporized on the distributor. When this light material vaporized, it caused extreme frothing and turbulence on the tray, which reduced its capacity. A column gamma scan confirmed the distributor flooding.

IPA and HCCO pumparound orifice-pan distributors were removed because they contributed significantly to poor fractionation. Both distributors were replaced with spray distributors, and the internal reflux was allowed to fall directly on the packing in pumparound Beds 2 and 4.

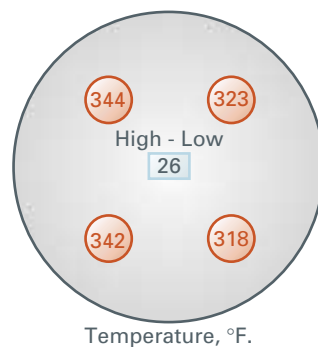
Fig. 4a

BP's main column was atypical because it had four outlet nozzles on the top head. During field testing, the temperature difference between the four nozzles was 26° F. (Fig. 4a). In other operating modes, the temperature difference increased to 35-40° F.

The 26° F. difference was due to a large composition gradient that reached the column's top through the gasoline-LCCO fractionation bed, which had

Fig. 4 shows the measured vapor temperatures leaving the four overhead vapor nozzles before and after the 2003 revamp. Before the revamp, vapor temperatures varied 26° F. and increased to as much as 35-40° F. during some modes of operation.

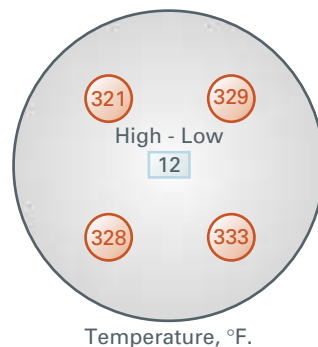
Fig. 4b

After the revamp, temperature variation decreased to 12° F.

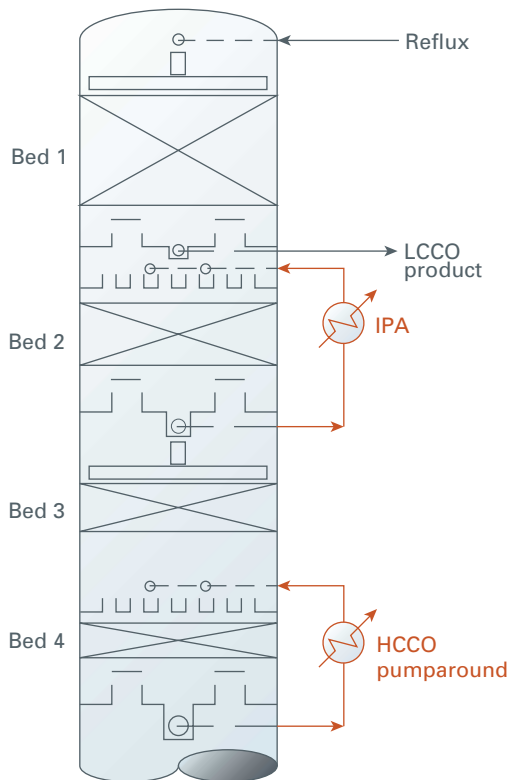
Fig. 3 shows the LCCO and IPA draw arrangement before the 2003 revamp. LCCO product was withdrawn above the IPA return.

Operation was stable as long as there was sufficient heat removal above the LCCO product draw to meet the product yield and allow some reflux to overflow the draw tray. LCCO stripper level was lost, however, when the total IPA, HCCO, and slurry pumparound heat removal was high enough to reduce internal reflux to zero (OGJ, Apr. 7, 1997, p. 62; Apr. 14, 1997, p. 47).

In this case, the top reflux rate and reflux subcooler duty were not high enough during warm weather to meet the LCCO product rate and allow some internal reflux flow from the product draw tray. Condenser limits and chronic problems with the cooling water supply to the reflux subcooler caused rapid exchanger fouling, which lowered subcooler duty.

During warm weather, BP increased the total slurry, HCCO, and IPA duties, which lowered the top reflux rate and internal reflux from the LCCO product draw. Once the internal liquid rate from the LCCO product draw tray reached zero, the product side-stripper lost level because the stripper bottom product flow controller was attempting to withdraw more LCCO product than was available as stripper feed.

The stripper liquid level was periodically lost, resulting in cavitation in the LCCO product pump. The operator, therefore, could not independently adjust the product flow rate because it depended on the main column heat balance.

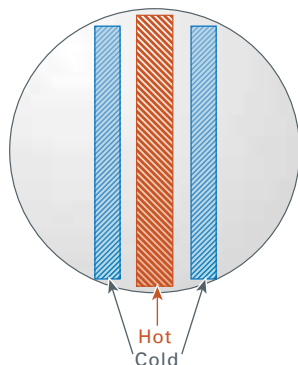
Fig. 5 shows the hot (red) and cold (blue) liquid streams that feed different sections of the orifice pan distributor.

The red box is the lone central downcomer from the LCCO product collector draw tray. The two outside blue boxes are 135° F. cold pumparound return liquid.

Gasoline-LCCO fractionation varied depending on IPA flow rate and whether the heat balance generated in internal reflux. The pan distributor, however, did not mix the hot and cold liquids except along the edge of the LCCO collector tray downcomer.

IPA duty was more than 50 MM-btu/hr and the pumparound condensed a large amount of vapor. The hot internal reflux still had little heat-removal capability; most condensation occurred where the cold IPA return stream flowed into the packing. Vapor leaving the central zone was therefore hotter and had a much higher end point than vapor leaving the packing above areas where cold IPA liquid was distributed. This high-end-point material entering the gasoline-LCCO bed degraded fractionation.

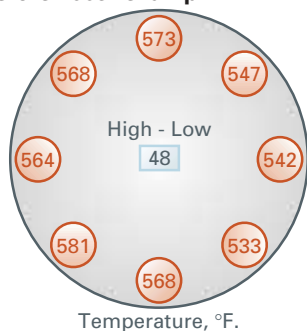
Fig. 8
Fig. 8a

Table 1 shows that the measured radial skin temperatures above gasoline-LCCO Bed 1, IPA Bed 2, and above the LCCO-heavy catalytic cycle oil (HCCO) Bed 3 varied 64° F., 85° F., and 48° F., respectively.

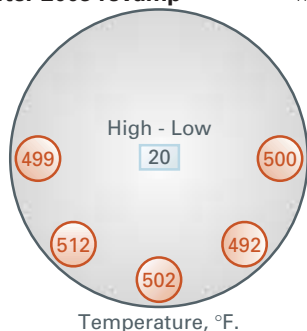
Fig. 8b

*Scaffolding was removed after the revamp, which permitted only five temperatures to be measured.

Radial temperatures measured above Bed 3 had less variation—to 20° F. from 48° F. (Fig. 8). Composition gradients generated from the HCCO pumparound orifice-pan distributor were greatly reduced. Temperatures were lower after the revamp because of the heat balance shift. ♦
