Revamping atmospheric crude heaters

The revamp of an atmospheric crude unit heater, which was suffering from coking caused by asphaltene precipitation and poor burner stability, resulted in a significantly increased heater run length

Michael Whatley *Navajo Refining Company*
Scott Golden and Jason Nigg *Process Consulting Services Inc*

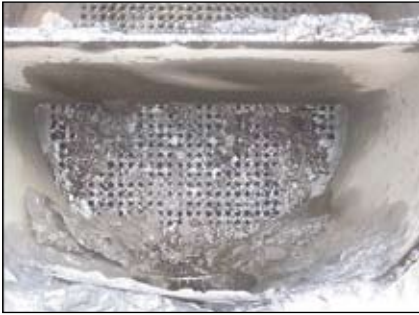
Figure 2 Fouled exchanger tubes — asphaltene precipitation

Asphaltene precipitation in crude preheat exchanger tubes is common. Figure 2 shows asphaltene precipitation inside the channel head and tubes in a unit processing West Texas crudes. In this case, the oil velocity inside the tubes was less than 5 ft/s and severe

fouling occurred. Exchangers operating at higher velocities in the same unit had less fouling. Moreover, the atmospheric heater downstream of the fouled exchanger had short heater runs, with TMTs increasing at 1°F/day. This rate of TMT rise is similar to a delayed coker heater. Crudes with poor asphaltene stability are especially difficult to process and the equipment must be carefully designed.

Maintaining a high velocity in the equipment minimises asphaltene precipitation. Crude preheat exchangers and heater tubes should be designed for oil velocities of 8–10 ft/s or higher. Experience shows significant improvements in crude preheat and heater reliability when velocities are high. Since many designers set the maximum allowable pressure drop through exchangers and the heater as design criteria, low velocities are often the result of meeting pressure drop specifications. Crude preheat exchangers and fired heater designs should be based on a higher velocity, with the pressure drop simply a result of the design.

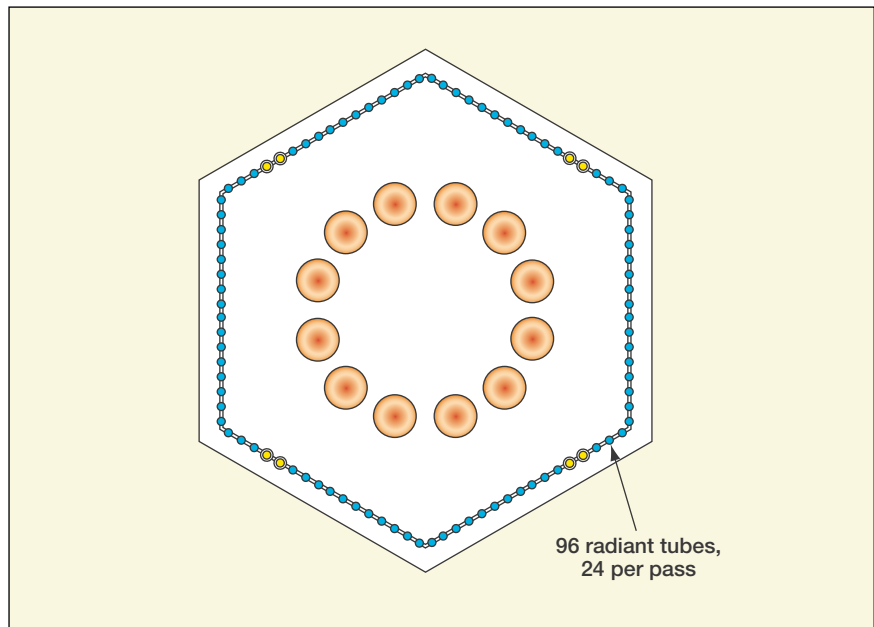
Figure 4 Burner floor before revamp

The revamped heater included a new convection section, completely retubed radiant section, new ULNB burners and floor. Prior to the revamp, heater performance showed the convection section was not performing well, radiant section tubes were fouled and the burners had poor flame stability. Poor convection performance was caused primarily by fin damage. Radiant section fouling was caused by asphaltene precipitation and poor burner stability resulting from the burners being too close together, causing adverse flame interaction.

poor flame stability. The heater had 12 burners that were spaced too close together (Figure 4). A completely new floor was installed with six larger burners, which eliminated flame interaction, producing a stable flame (Figure 5). These burners were latest-generation ULNB burners.
