De-entrainment and washing of flash-zone vapors in heavy oil fractionators

Extensive troubleshooting experience shows what methods are most successful

D. W. Hanson, Process Consulting Services Inc., Houston, Texas; and **N. P. Lieberman** and **E. T. Lieberman**, Process Improvement Engineering, Metairie, Louisiana

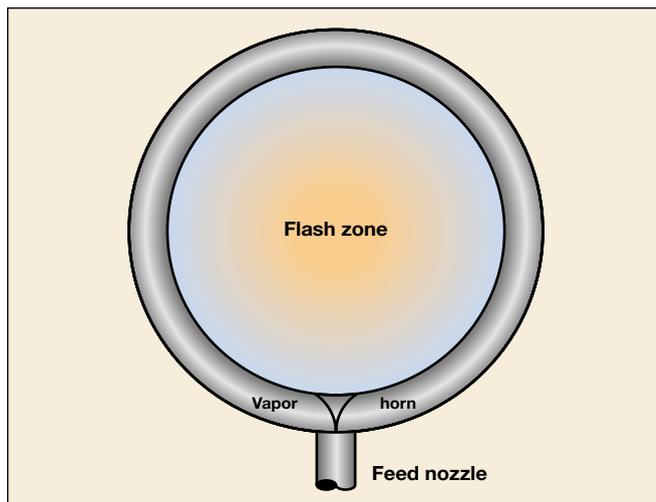
Fig. 4. Radial flow vapor horn schematic.

Vapor distribution. When discussing reasonable and obtainable entrainment velocities or *C-factors*, initial vapor distribution is the most important factor and must be considered. In one virgin vacuum column, we observed a *C-factor* of 0.5 fps without excessive entrainment. Another virgin vacuum column had terrible entrainment at a *C-factor* of 0.3 fps prior to revamp. We have revamped towers operating at 0.43 fps *C-factors* to address vapor distribution, and were able to push post-revamp capacities and lift to a *C-factor* of 0.46 fps with lower entrainment. More entrainment in the flash zone means more rapid coke formation, since the rate of flash-

zone and wash-zone coking is proportional to entrainment rates.

- Keeping the feed inlet nozzle top at least 5 ft below the overflash draw pan
- Designing dual inlets for large-diameter towers over 20 ft in diameter
- Minimizing the width of the vapor horn distributor
- Using internal "cut-off" baffles inside the horn
- Using internal "swirl vanes" to aid in vapor distribution
- Using radial entry and split-flow vapor horns (Fig. 4) for smaller-diameter towers rather than tangential entries
- Providing for emergency internal overflow pipe from the overflash pan
- Designing the overflash pan with many small chimneys to function as a vapor distributor with significant pressure drop.
