Field Data, New Design Correct Faulty FCC Tower Revamp

In 1987, Lyondell Petrochemical Co. revamped a fluid catalytic cracking unit (FCCU) main fractionator by replacing trays with structured packing. This revamp did not achieve its design objectives; therefore, a second revamp was performed in 1992. Packing large diameter main fractionators can increase unit capacity and decrease pressure drop while meeting fractionation objectives. However, a packed main fractionator revamp is less forgiving than a trayed column revamp and must take into consideration proper design and inspection procedures. Lyondell's experience illustrates the approach needed to have a successful structured packing revamp.

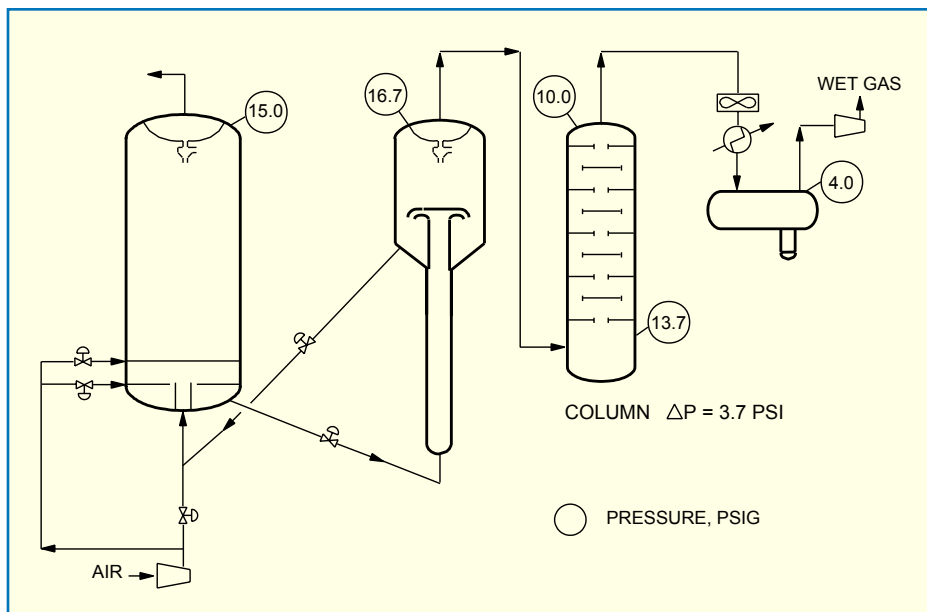
Figure 2 FCC Pressure Balance (Trayed Column)

Reactor-regenerator pressure balance is affected by main column pressure drop. (Figure 2) Before the revamp, unit capacity and conversion had been limited by low cat-to-oil ratio. Reducing pressure drop would allow lower reactor operating pressure, which permits higher catalyst circulation and increased conversion. The revamped unit pressure-balance also permitted lower regenerator pressure.^{1,2} The revamp included a new regenerator air grid design that would generate higher pressure drop; therefore, the regenerator pressure had to be lowered to maintain the air blower discharge pressure at the required level to meet the regenerator air requirements.

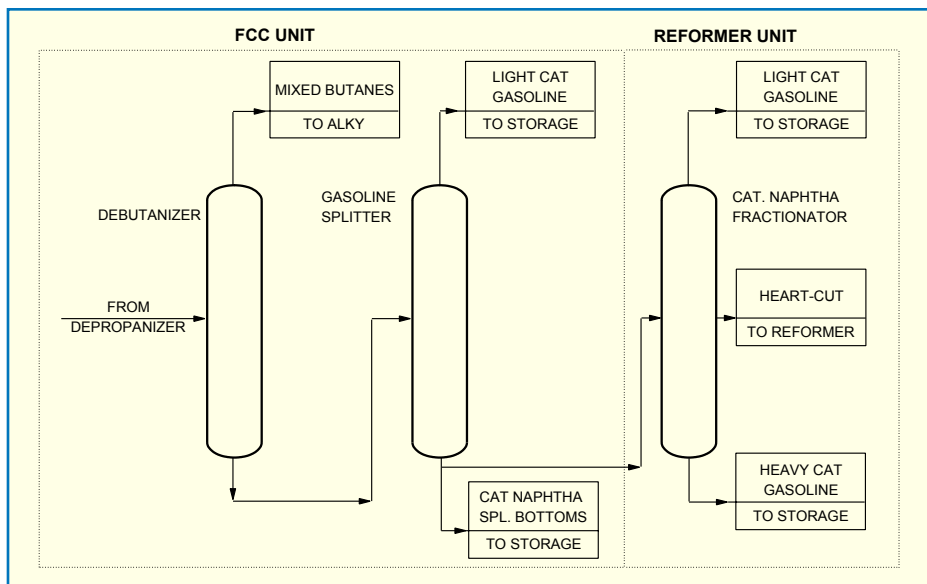
Figure 3 FCC Gasoline Fractionation System

The project justification was increased charge rate, higher gasoline production, and lower pressure drop. The main fractionator raw gasoline (liquid product from overhead receiver) had a high endpoint and the light cycle oil (LCO) product contained 2,400 b/d of recoverable gasoline. The gas plant fractionates full range gasoline into light, middle (heart-cut), and heavy gasoline prior to blending or reprocessing (Figure 3).

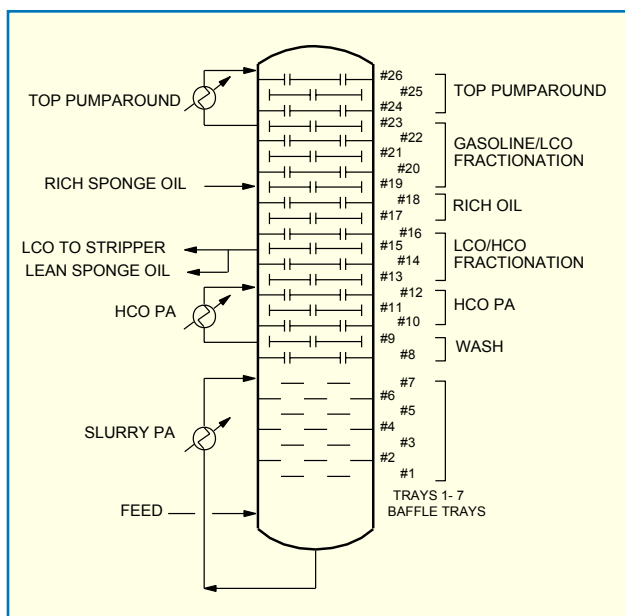
Figure 5 Trayed Columns, Capacity 79,000 B/D

The original column design used trays, which limited FCC feed to 79,000 b/d (Figure 5). The measured trayed column pressure drop was 3.7 psi. At 79,000 b/d, 75% conversion, and test run heat and material balance conditions, the calculated pressure drop using the column internal loadings was 3.6 psi. The stated revamp objective was a 15% increase in feed rate while maintaining fractionation comparable or better than the trayed column. Minimizing column pressure drop consistent with these stated objectives had product conversion benefits. Reduced pressure drop allowed adjustments in the reactor/regenerator pressure profile. These adjustments enabled Lyondell to increase the catalyst-to-oil ratio with a corresponding increase in unit conversion and selectivity. The regenerator pressure was lowered, permitting higher air grid pressure drop without reducing air blower capacity.
