Correcting Design Errors Can Prevent Coking in Main Fractionators

Scott W. Golden

Norm Lieberman

Gary R. Martin

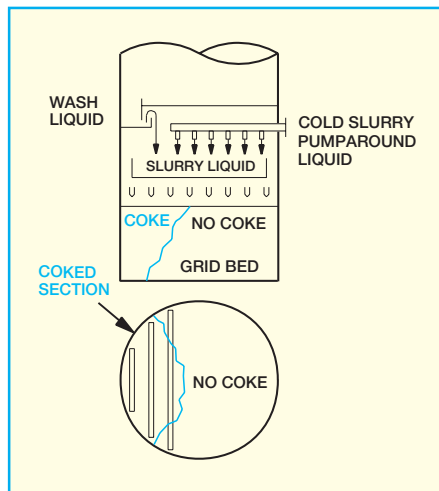
Figure 5. FCC Main Fractionator

The liquid distributor design preferentially fed the wash liquid to one section of the packing and the slurry pumparound liquid to another. Inspection of the packing

showed localized coking only in the area where wash liquid was distributed. Thus, the bed coked because wash section liquid and the slurry pumparound were not mixed (**Figure 5**). While similar distributor designs have been used in many other FCCs, this one resulted in localized coke formation because the liquid rate leaving the wash section was very high due to column heat balance. Modifications to the liquid distributor improved mixing of the wash liquid and slurry pumparound and the unit has operated for many years without coking.

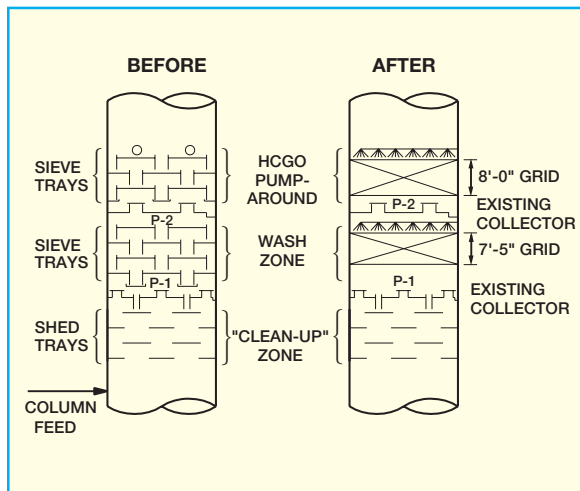
Figure 6. Delayed Coker Fractionator Revamp

A delayed coker main fractionator (**Photo 4**) wash section was revamped from tray to packing to increase unit charge rate and reduce recycle rate. Four sieve trays were replaced with an 8-ft. bed of grid. However the packing began to coke after less than 6 months of operation. The packed bed pressure drop increased from 6 inches of water just after start up to over 32 inches after only 6-month period. **Figure 6** shows the column before and after the revamp. To reduce the initial revamp costs, the collector tray under the wash bed was not modified and the shed trays below the collector were not removed (**Photo 5**).

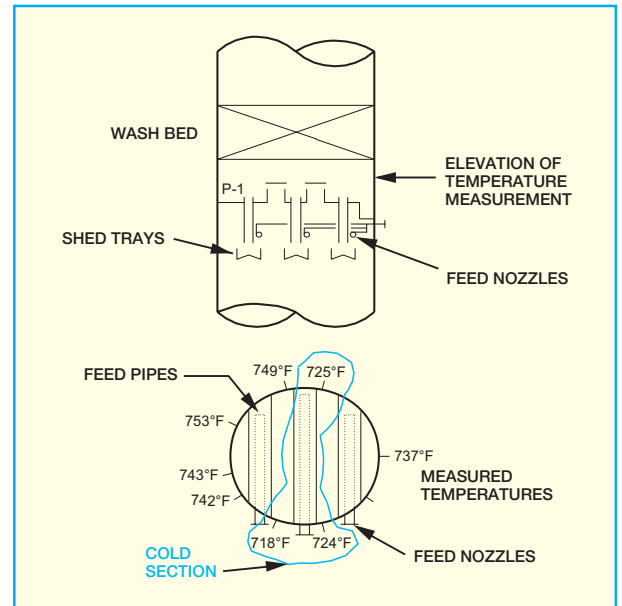
Figure 8. Coker Fractionator Radial Temperatures

Measuring radial temperature profile is a good method to infer liquid and vapor distribution. The radial temperature survey below the packing had high to low temperature variation of 40°F. (Figure 8). Yet, the temperature drop across the wash section with uniform liquid and vapor distribution would be only 40°F. Furthermore, the wash zone liquid rate to the top of the packed bed was only 1.0 gpm/ft² when feeding 9,000 b/d of cold HCGO. Over half

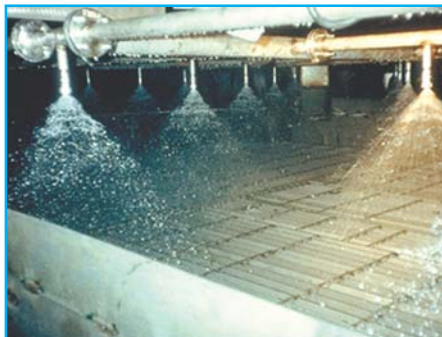
Photo 6. Spray Header Testing

Pressure drop is a measure of flow rate and/or restriction in any piping distribution system. The measured pressure drop across the wash zone spray header indicated that none of the spray nozzles were plugged (Photo 6) because the developed pressure drop was very close to the manufacturer's specified pressure drop. However the measured pressure across the shed tray feed pipes was 120 psi and the cold HCGO control valve was wide open. Also, two of the three feed lines were cold to the touch, thus there was no flow. The calculated pressure drop for one feed pipe was only 5 psi but the measured pressure drop was 120 psi.

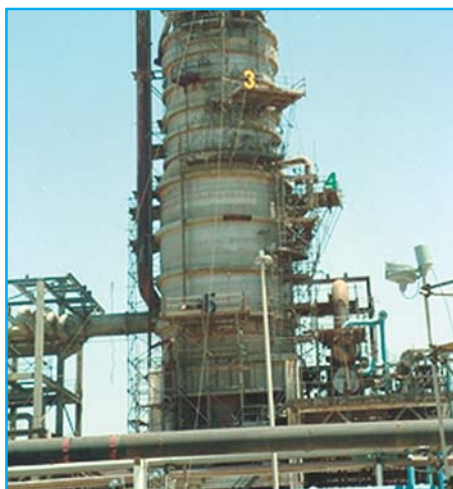
Photo 8. Vacuum Column

Deep-cut, vacuum column (Photo 8) revamps are common today, but many units shut down to replace coked wash sections. Often these columns are shut down more than once because the cause of the problem is not determined.

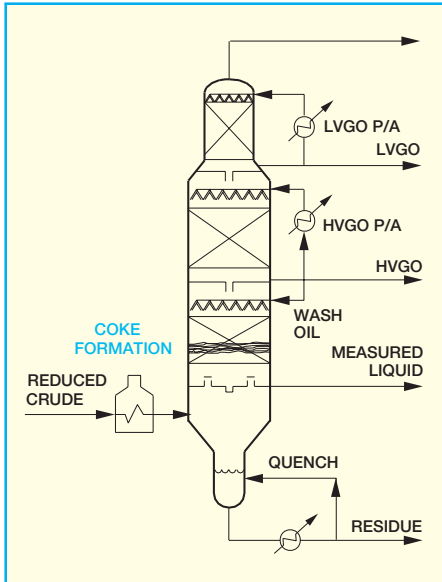
Figure 11. Crude Vacuum Washzone Coking

black. When the pressure drop increases to 8-10 mm Hg, gas oil quality will be very poor. Pressure drops as high as 80 mm Hg have been measured across vacuum columns wash sections (Photo 9).
