Revamping FCC Units: Debutanizer Reboiler Fouling

Don't Treat the Symptoms

TONY BARLETTA, Process Consulting Services, Inc., Houston, TX

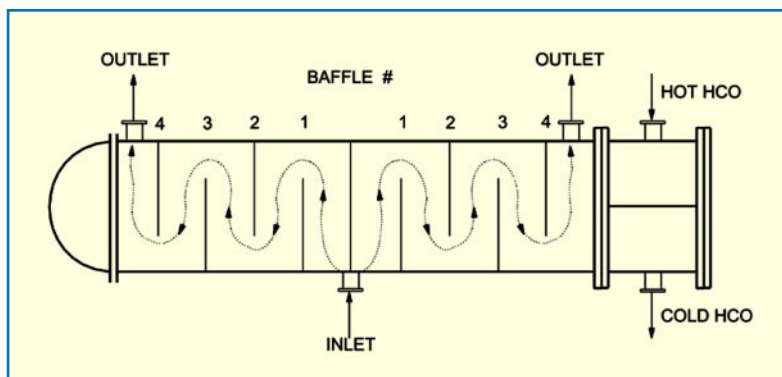
Figure 1. "J" type thermosyphon reboiler.

reduce the rate of fouling or eliminate it. Figure 1 shows a typical J-type shell reboiler that uses main fractionator HCO and/or slurry streams for heat. HCO and slurry stream temperatures will vary from 540°F to 700°F depending on the process flow scheme, column heat balance and operating philosophy. Main column slurry streams contain FCC catalyst fines and a high concentration of asphaltenes that contribute to low heat transfer, so it is natural to assume tube-side fouling causes poor reboiler performance.

Often, refiners assume fouling is mainly on the tube-side because both slurry and HCO streams have a high fouling tendency. But this can be a mistake. Refiners that clean the tubes in-place but do not clean the shell-side may find that heat transfer coefficients in the exchanger are still low, and debutanizer performance suffers.
