Pump cavitation caused by entrained gas

Here's how the problem was solved on an FCC main fractionator

T. BARLETTA, Process Consulting Services, Houston, Texas

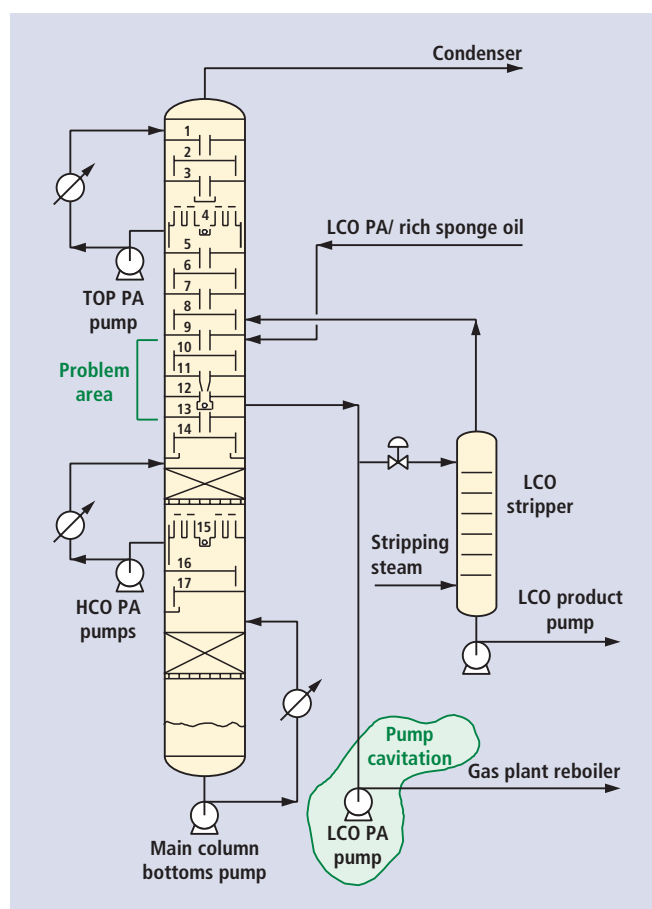
FIG. 1. The four pumparounds include TOP, LCO, HCO and slurry PA.

Fig. 1 shows the main process flow scheme with four pumparounds including TOP, LCO, HCO and slurry PA. The revamp design basis would shift heat removal from lower pumparounds to the TOP PA to raise reflux between gasoline and LCO product draws. Since the HCO and LCO pumparounds are used for gas plant reboiler heat, their duties could not be
