Revamp improves FCC performance at BP's Texas City refinery

Scott W. Golden
Daryl W. Hanson
Process Consulting Services Inc.
Houston

Joy Hansen
Mike Brown
BP Products Co.
Texas City, Tex.

In early 2003, BP Products Co. revamped its Texas City, Tex., refinery. Changes to FCC Unit 1 reduced the true boiling point distillation curve's 90%-final boiling point tail for the heavy catalytic naphtha (HCN) to 36° F. from 58° F., lowered gasoline sulfur content,¹ and improved gasoline recovery from the light catalytic cycle oil (LCCO) by 800 b/d.

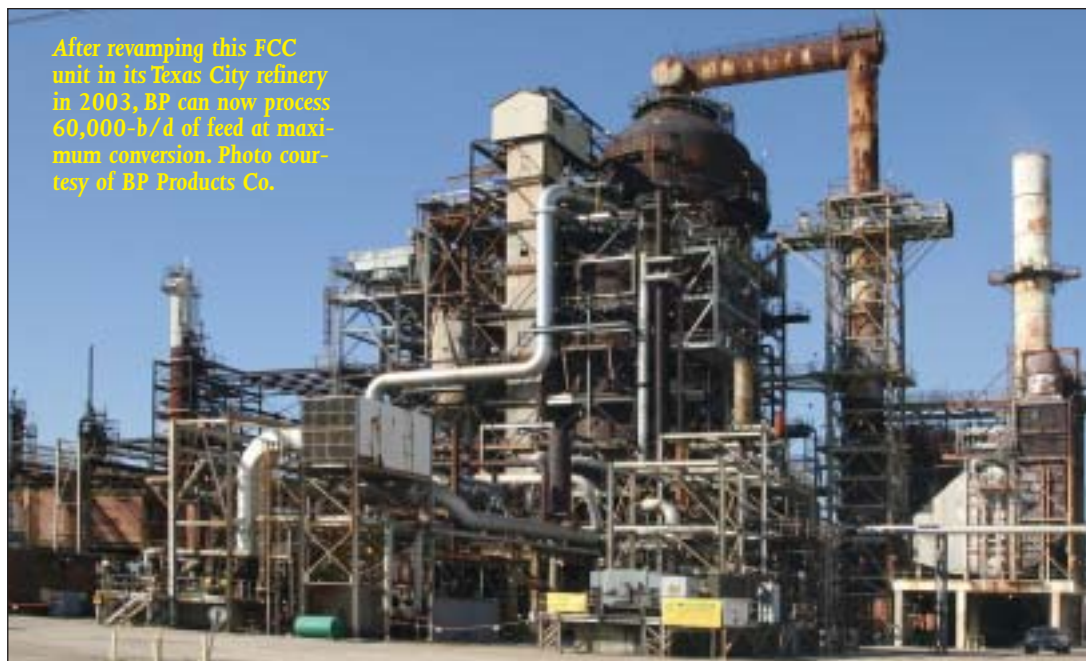
BP's main column was atypical because it had four outlet nozzles on the top head. During field testing, the temperature difference between the four nozzles was 26° F. (Fig. 4a). In other operating modes, the temperature difference increased to 35-40° F.

Fig. 4 shows the measured vapor temperatures leaving the four overhead vapor nozzles before and after the 2003 revamp. Before the revamp, vapor temperatures varied 26° F. and increased to as much as 35-40° F. during some modes of operation.
