Revamping atmospheric crude heaters

The revamp of an atmospheric crude unit heater, which was suffering from coking caused by asphaltene precipitation and poor burner stability, resulted in a significantly increased heater run length

Michael Whatley *Navajo Refining Company*
Scott Golden and Jason Nigg *Process Consulting Services Inc*

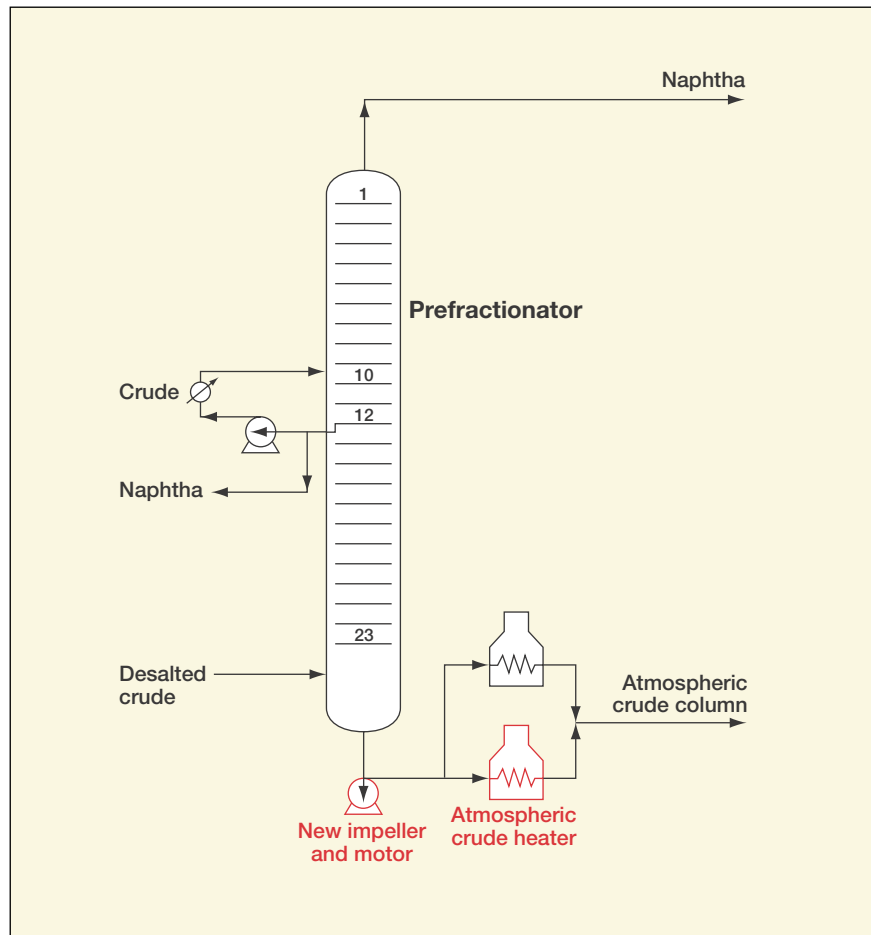
Figure 3 Increased system pressure drop

Crude stability is a function of its source and highly variable. However, the designer can influence the process and equipment design to minimise the effect of poor asphaltene stability. In some cases, the material deposits inside the exchangers, piping, heater tubes or fractionation column. The lower the velocity, the more likely it is that asphaltenes will precipitate. In this example, the oil velocity inside the heater

tubes was only 5.5–6 ft/s prior to the oil vapourising, which corresponds to a 250 lb/sec-ft² oil mass flux. At these velocities, whether in an exchanger or heater tube, asphaltenes will likely drop out. Heat exchanger data gathered from hundreds of operating exchangers shows the rate of fouling and the ultimate fouling factor are to a large extent determined by the velocity of the crude flowing through the tubes (assuming no shell-side design problems).
